Technical product information

Topic	Rotating display/screen - Fault diagnosis - Mechanical malfunction DTC B140107 is evident within 005F
Market area	Russische Föderation (5RU),Australia E04 Bentley rest Asia and Australia (6E04),China 796 VW Import Comp. Ltd (Vico), Beijing (6796),Germany E02 Bentley rest Europe (6E02),Japan E03 Bentley Japan (6E03),Korea, (South) E08 Bentley South Korea (6E08),United Arab Emirates E06 Bentley Middle East and Africa (6E06),United Kingdom E01 Bentley UK (6E01),United States E05 Bentley USA and rest America (6E05)
Brand	Bentley
Transaction No.	2067955/1
Level	EH
Status	Approval
Release date

- Bentley Rotational Display (BRD) operational issues
- Mechanical malfunction DTC B140107 evident within 005F

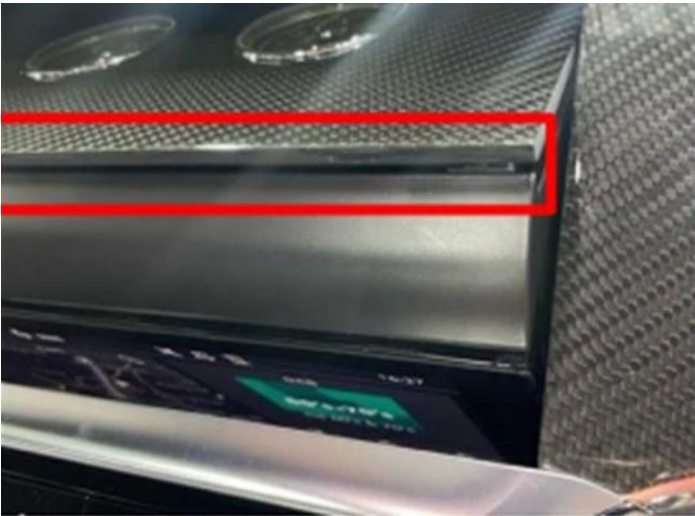
Figure 1

4) Conduct a visual check to ensure that the display clocks, dials fascia and veneer fascia are not unclipped from the rotating display assembly (Figures 1 and 2 show an example of the display clocks and/or dials fascia unclipped)

5) Referring to Rep.Gr91 - Remove the applicable fascia (Display clocks, dials fascia and/or Veneer fascia)

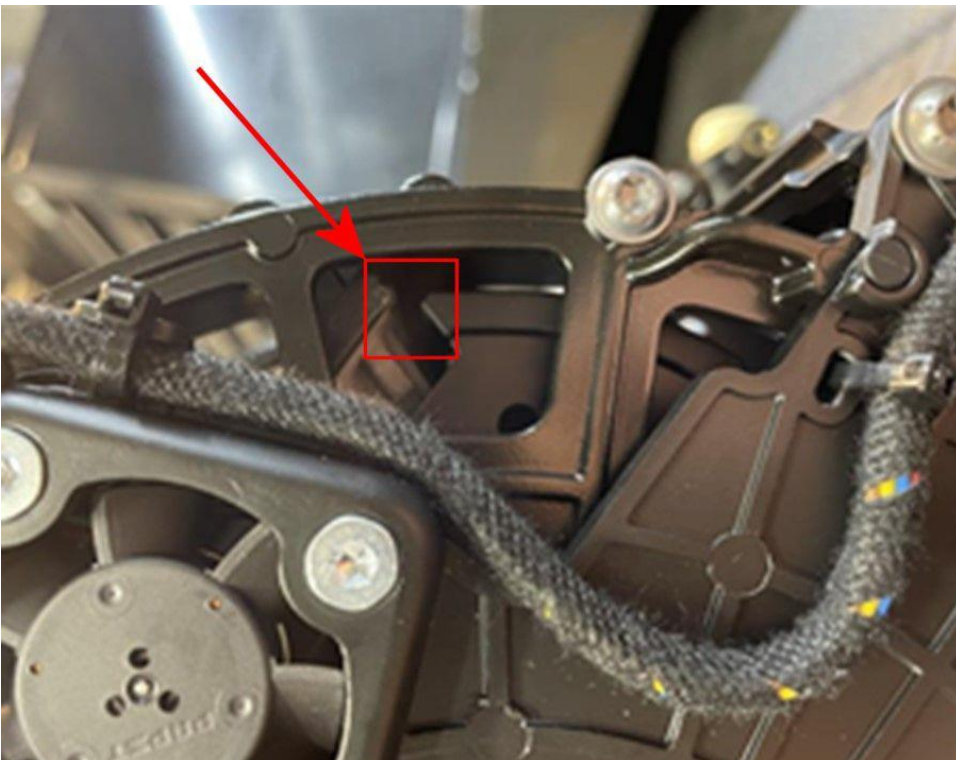
Figure 2

Please note: The BRD must be removed (Rep.Gr 91) to allow visual inspection of the panel at the back of the BRD for signs of unclipping (Figure 2)

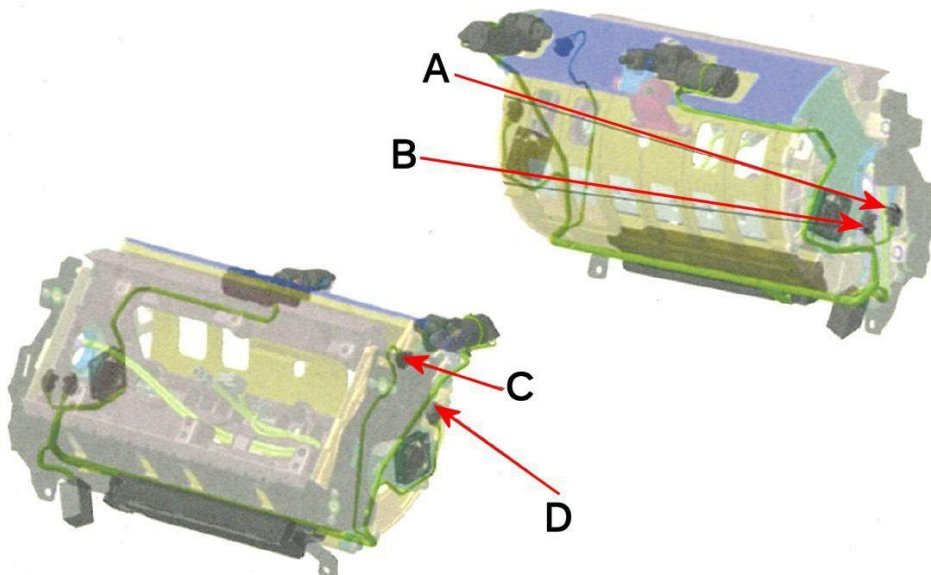
Figure 4 shows the location of each BRD switch (A to D) as follows: A

- Rotational gauge fascia position

B - Rotational veneer fascia position

C - Longitudinal deployed position

D - Longitudinal rotation position

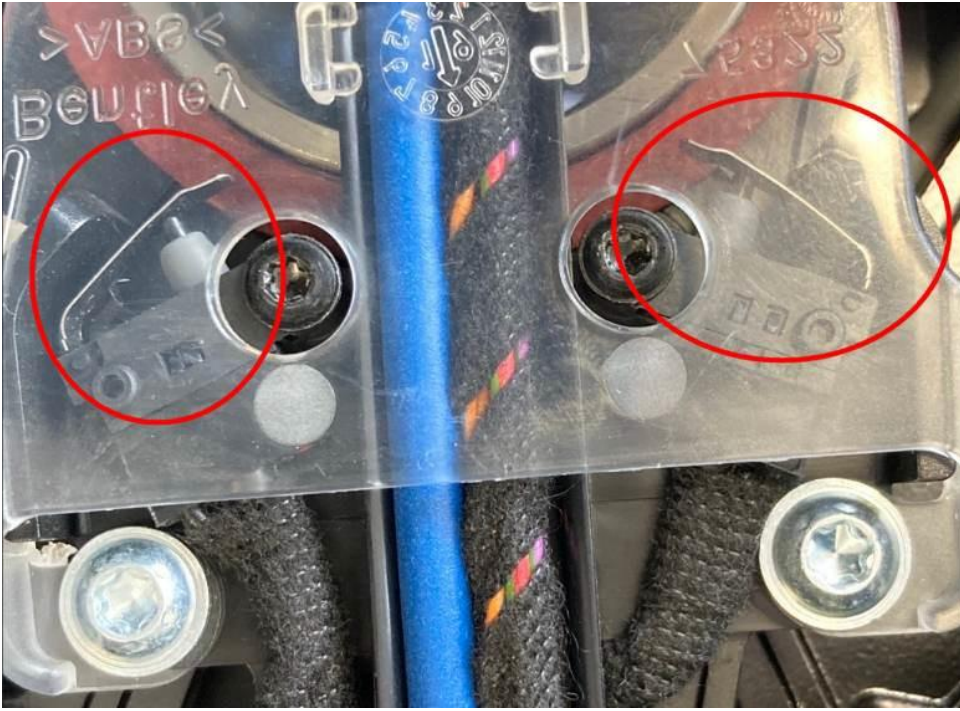
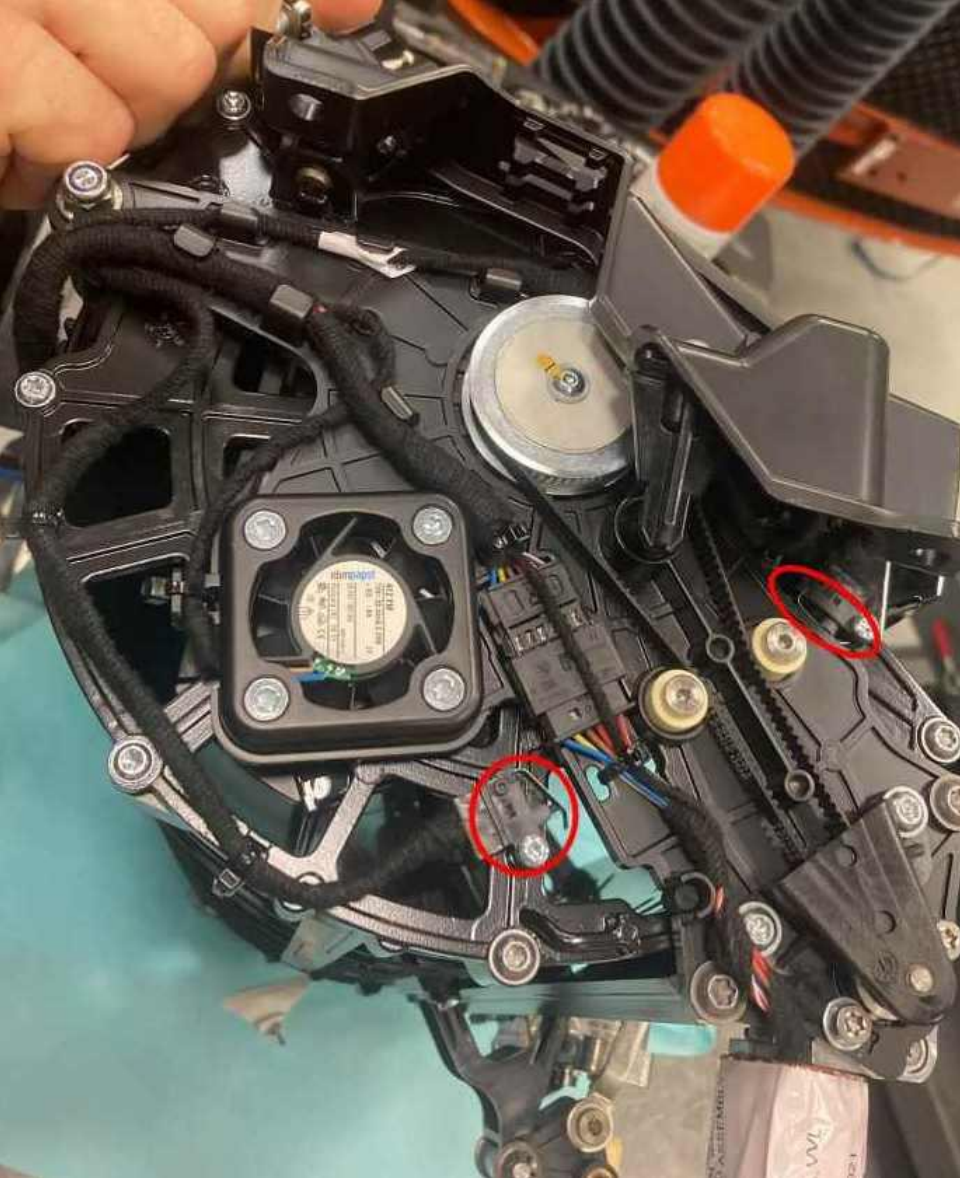
Referring to Figures 5 and 6 check/confirm the condition of the micro switches checking for any abnormalities for example damage and/or striker misalignment

Please note: The micro switch examples shown in Figures 5 and 6 are to specification

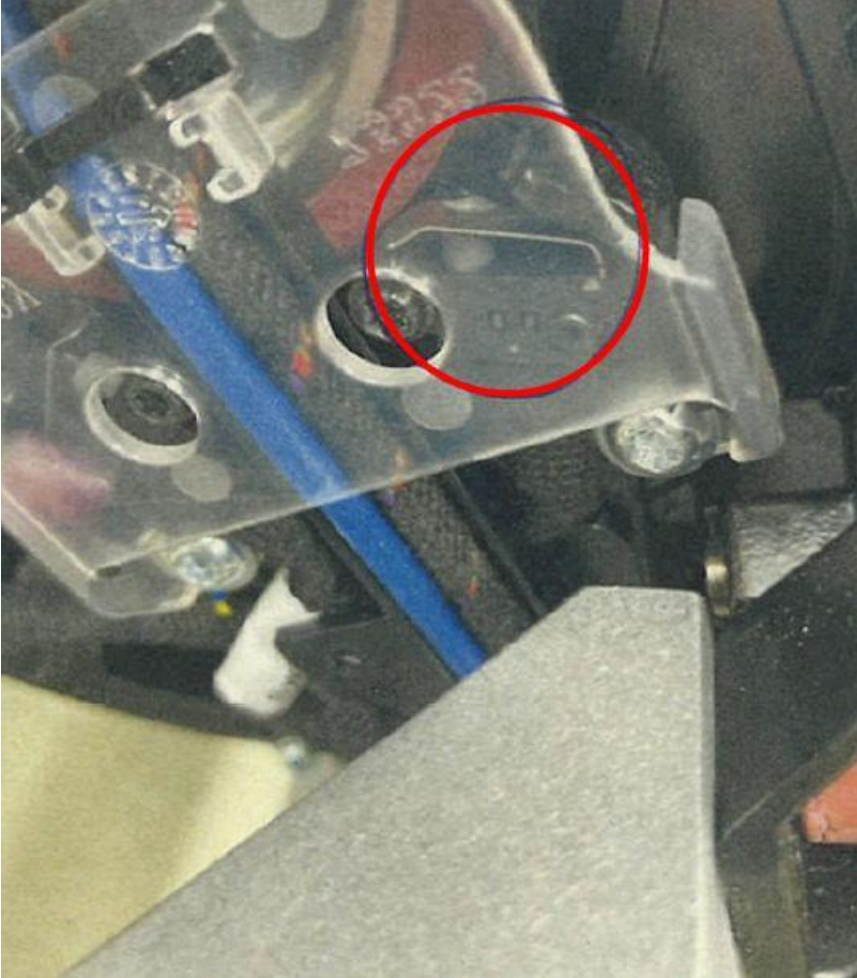
NOTE: Figure 7 shows an example of striker misalignment and switch damage

NOTE: Should any of the previously suggested steps not have been successful please raise a new Technical DISS query or respond via an existing query ensuring all images and videos of the issue including the battery test results and a current ODIS log are attached and await feedback before conducting any further work
