## Technical product information

<b>Topic</b>	During PDI - Steering wheel vibration and/or steering wheel out of alignment is evident
<b>Market area</b>	Russische Föderation (5RU),Australia E04 Bentley rest Asia and Australia (6E04),China 796 VW Import Comp. Ltd (Vico), Beijing (6796),Germany E02 Bentley rest Europe (6E02),Japan E03 Bentley Japan (6E03),Korea, (South) E08 Bentley South Korea (6E08),United Arab Emirates E06 Bentley Middle East and Africa (6E06),United Kingdom E01 Bentley UK (6E01),United States E05 Bentley USA and rest America (6E05)
<b>Brand</b>	Bentley
<b>Transaction No.</b>	2060223/5
<b>Level</b>	EH
<b>Status</b>	Approval
<b>Release date</b>

### New Continental GT/C - New Flying Spur - Bentayga Series

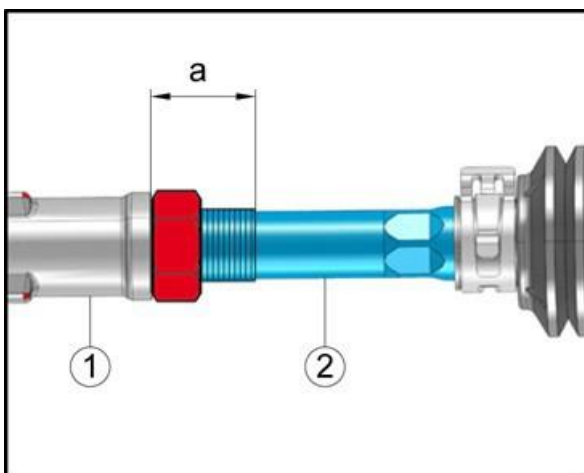
- Tyre Pressures to be recorded and checked against the correct specification – Actual results should be requested and attached to the DISS query
- Referring to Figure 1 - Images of the track rod end threads before and after alignment from both sides should be requested and attached to the open DISS query
- *Measure and note down dimension -a- between the track rod ball joint -1- and the track rod -2- on both sides.*
