Technical product information

Topic	Night vision camera - Washer jet leaking
Market area	Bentley: worldwide (2WBE)
Brand	Bentley
Transaction No.	2051045/6
Level	EH
Status	Released for publishing
Release date	02-Nov-2022

Washer fluid dripping/leaking from the night vision camera washer jet

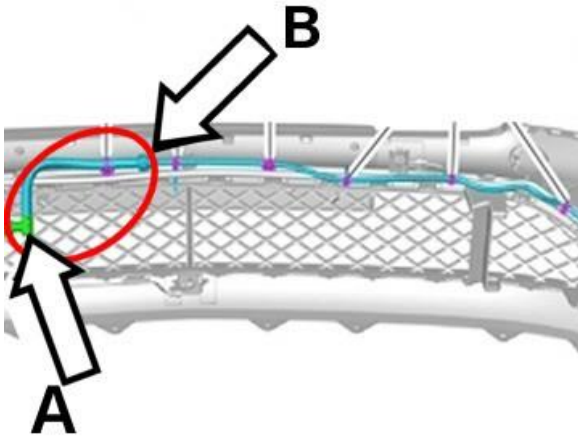
Referring to Figure 1 - In the event the aforementioned symptom is evident the operative should refer to the Measure section of this TPI to replace the night vision washer jet (short link hose - Circled) which connects the night vision camera washer jet (A) to the washer jet supply hose connector (B)
