Technical product information

Topic	V8 Kovomo - Engine misfires - Engine management light illuminated within the DIP
Market area	Russische Föderation (5RU),Australia E04 Bentley rest Asia and Australia (6E04),China 796 VW Import Comp. Ltd (Vico), Beijing (6796),Germany E02 Bentley rest Europe (6E02),Japan E03 Bentley Japan (6E03),Korea, (South) E08 Bentley South Korea (6E08),United Arab Emirates E06 Bentley Middle East and Africa (6E06),United Kingdom E01 Bentley UK (6E01),United States E05 Bentley USA and rest America (6E05)
Brand	Bentley
Transaction No.	2064776/4
Level	EH
Status	Released for publishing
Release date	04-Nov-2022

V8 Kovomo engine

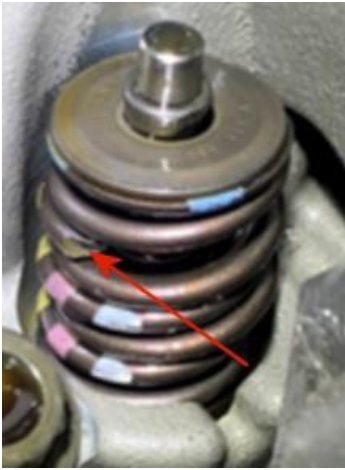
- Referring to Figure 1 - Take clear photos of the broken valve spring (from the affected cylinder head only)

VERY IMPORTANT: Ensure the photos show the location in which the valve spring is broken (ARROW) the various paint markings should also be captured
