Technical product information

Topic	W12 Engine management light on - Turbocharger speed sensor DTC's stored
Market area	Bentley: worldwide (2WBE)
Brand	Bentley
Transaction No.	2053348/9
Level	EH
Status	Released for publishing
Release date	09-Nov-2022

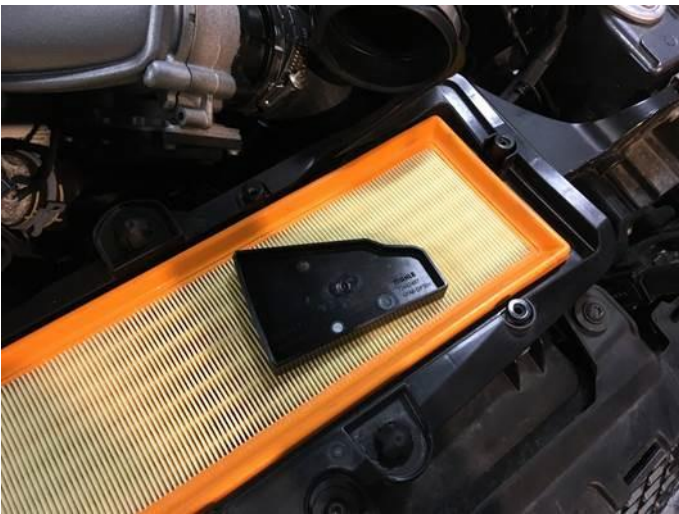
- Inspect for damage or missing components NOTE: The example in Figure 1 shows an air filter box divider that has become detached, causing DTC-P259400: Turbocharger Speed Sensor "B" - Circuit Range/Performance
- Reattach the divider and retest the vehicle if this particular fault is found
