Technical product information

Topic	W12 - Oil leak from engine
Market area	Bentley; worldwide (2WBE)
Brand	Bentley
Transaction No.	2053350/4
Level	EH
Status	Released for publishing
Release date	09-Nov-2022

New Continental GT/C and New Flying Spur

Bentayga

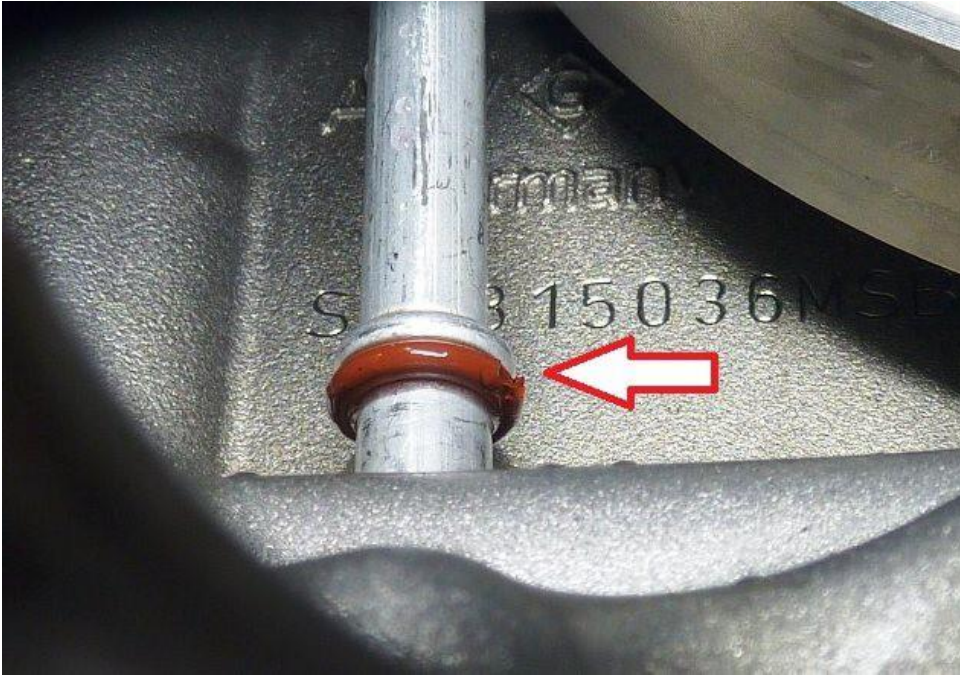
The breather return line and the oil dipstick tube O-rings can split causing an external oil leak.

This can be misdiagnosed as the engine sump leaking.

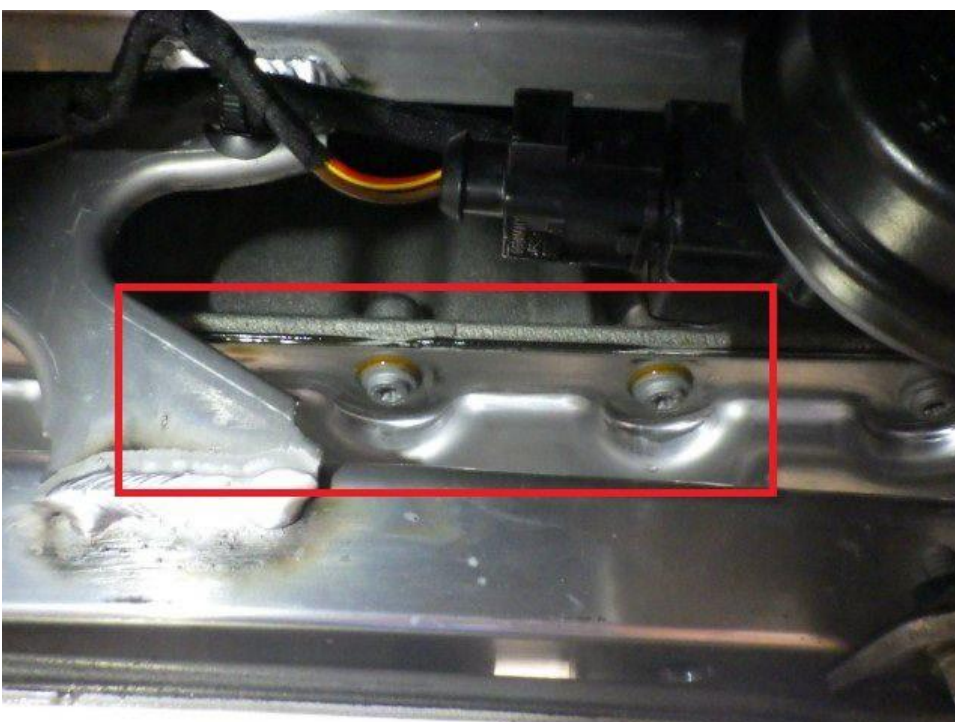
Figure 1

If an engine oil leak is found from the area shown in Figure 1, check the O-rings of both the breather return line and the dipstick tube for leakage. The oil can run down the engine and settle on the sump leading to misdiagnosis, Figure 1.

Should either of the O-rings be damaged or leaking replace according to ETKA.
