Technical product information

Topic	Bentayga - Air suspension warning light within the DIP - DTC's P089200 - C104707 - C103B13 - Evident within Address 74
Market area	Russische Föderation (5RU),Australia E04 Bentley rest Asia and Australia (6E04),China 796 VW Import Comp. Ltd (Vico), Beijing (6796),Germany E02 Bentley rest Europe (6E02),Japan E03 Bentley Japan (6E03),Korea, (South) E08 Bentley South Korea (6E08),United Arab Emirates E06 Bentley Middle East and Africa (6E06),United Kingdom E01 Bentley UK (6E01),United States E05 Bentley USA and rest America (6E05)
Brand	Bentley
Transaction No.	2062261/4
Level	EH
Status	Released for publishing
Release date	02-Nov-2022

Air suspension warning light within the DIP

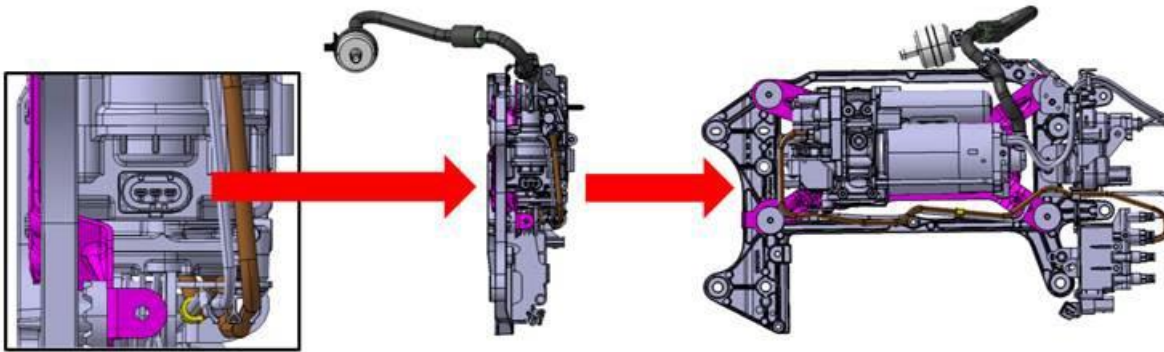
NOTE: NX7 is located as shown in Figure 1 (On the air supply unit/opposite side to the valve block)

- Conduct a wiring integrity check between the Valve block for adaptive suspension control unit (NX7) and the Running gear control unit (J775)
