Technical product information

Topic	Creaking/squeak noise from the front suspension (upper inner lever bushes)
Market area	Russische Föderation (5RU),Australia E04 Bentley rest Asia and Australia (6E04),China 796 VW Import Comp. Ltd (Vico), Beijing (6796),Germany E02 Bentley rest Europe (6E02),Japan E03 Bentley Japan (6E03),Korea, (South) E08 Bentley South Korea (6E08),United Arab Emirates E06 Bentley Middle East and Africa (6E06),United Kingdom E01 Bentley UK (6E01),United States E05 Bentley USA and rest America (6E05)
Brand	Bentley
Transaction No.	2064779/2
Level	EH
Status	Released for publishing
Release date	03-Nov-2022

Bentayga series

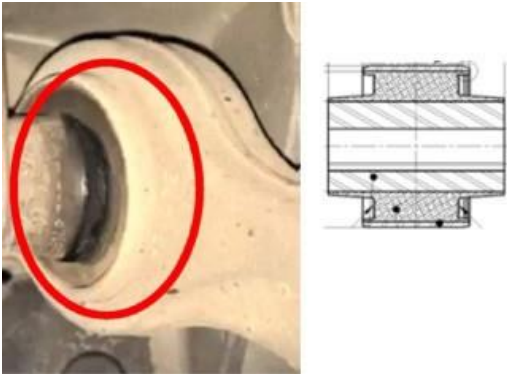
Figure 1

Defective upper inner lever bush (Figure 1)

The noise present in the sound file is caused by defective upper inner lever bush/bushes, the noise can appear in the following possible scenario

- When the vehicle is moved with steering input over uneven surfaces (for e.g. a ramp or speed bump)

1) Replace the left hand front (x2) and right hand front (x2) upper inner lever bushes - Refer to Repair manual Rep.Gr.40 front suspension, upper lever bush/bushes - to remove and fit

Carry out wheel alignment and ensure the driver assist system calibrations are performed as follows:
