Technical product information

Topic	Squeaking/creaking noises from the front axle and/or leaks at the lower ball joint/s
Market area	Russische Föderation (5RU),Australia E04 Bentley rest Asia and Australia (6E04),China 796 VW Import Comp. Ltd (Vico), Beijing (6796),Germany E02 Bentley rest Europe (6E02),Japan E03 Bentley Japan (6E03),Korea, (South) E08 Bentley South Korea (6E08),United Arab Emirates E06 Bentley Middle East and Africa (6E06),United Kingdom E01 Bentley UK (6E01),United States E05 Bentley USA and rest America (6E05)
Brand	Bentley
Transaction No.	2065197/2
Level	EH
Status	Released for publishing
Release date	03-Nov-2022

Bentayga Series

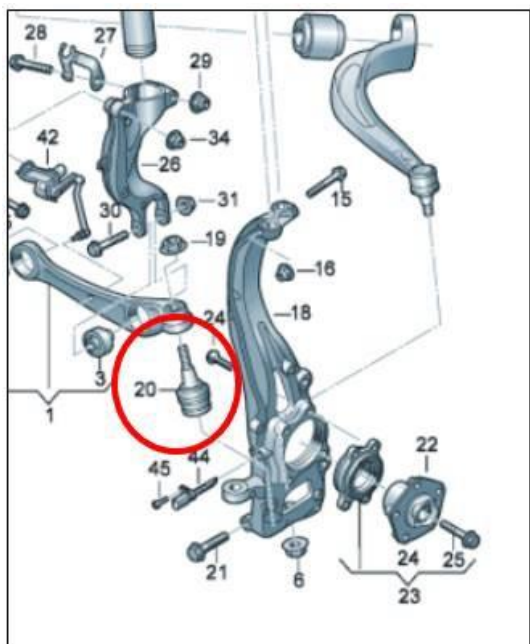
Figure 1

A leak is visible at the boot of the lower ball joint (grease emerging) however the boot does not show any damage

The noises can be assigned to the lower ball joint on the left and/or right side (Figure 1 - item 20).

Leak at the boot of the lower ball joint on the left and/or right side (Figure 1 - item 20) is visible however the boot is undamaged.

1) Referring to Rep.Gr 20 - Replace the left and/or right side lower ball joint

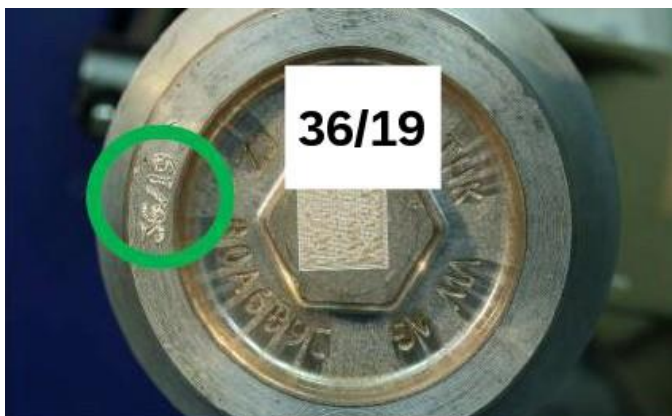
Make sure that the production date of the new ball joint is 36/19 or later (see date code example circled in Figure 2 - Week 36 of 2019).
