## Technical product information

<b>Topic</b>	Bentayga - PDC system not working or PDC system false detection
<b>Market area</b>	Russische Föderation (5RU),Australia E04 Bentley rest Asia and Australia (6E04),China 796 VW Import Comp. Ltd (Vico), Beijing (6796),Germany E02 Bentley rest Europe (6E02),Japan E03 Bentley Japan (6E03),Korea, (South) E08 Bentley South Korea (6E08),United Arab Emirates E06 Bentley Middle East and Africa (6E06),United Kingdom E01 Bentley UK (6E01),United States E05 Bentley USA and rest America (6E05)
<b>Brand</b>	Bentley
<b>Transaction No.</b>	2059392/3
<b>Level</b>	EH
<b>Status</b>	Released for publishing
<b>Release date</b>	02-Nov-2022

- PDC system not working or PDC system false detection
- Warning evident within the DIP

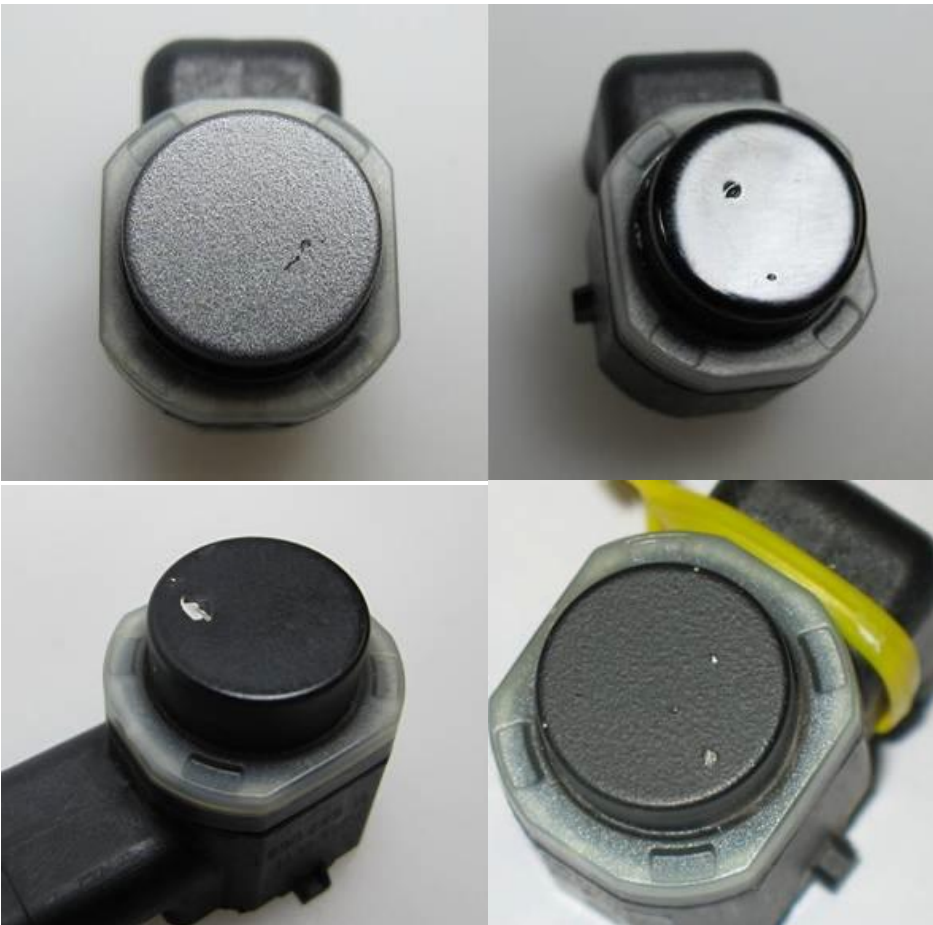
Parking sensor damage

8. External check of parking sensors for:
- Dirt, ice, foreign bodies, foil stuck on
  - Check any damage on the bumper, air inlet grille and underbody which may indicate a parking accident
  - Mechanical damage (stone chips, scratches)

IMPORTANT: With the following examples stone chips led to the failure of the sensor:

Stone chips and scratches are not complaints in the sense of warranty. Therefore dirty sensors should be cleaned and not replaced

Any sensors which are replaced for stone chips, scratches or any other type of damage will not be approved for warranty payment

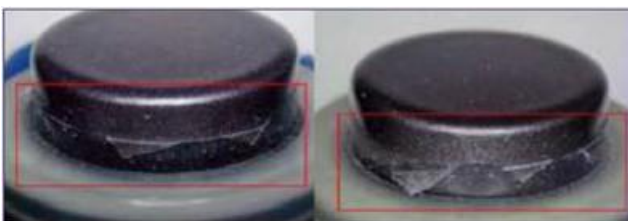
Paint overspray

9. when painting sensors ensure to paint within area specifications, removable layers of paint on the membrane can lead to false signals
