# Technical product information

<b>Topic</b>	Warning evident within the DIP for the steering system - DTC U103100 evident within diagnostic address 0044
<b>Market area</b>	Russische Föderation (5RU),Australia E04 Bentley rest Asia and Australia (6E04),China 796 VW Import Comp. Ltd (Vico), Beijing (6796),Germany E02 Bentley rest Europe (6E02),Japan E03 Bentley Japan (6E03),Korea, (South) E08 Bentley South Korea (6E08),United Arab Emirates E06 Bentley Middle East and Africa (6E06),United Kingdom E01 Bentley UK (6E01),United States E05 Bentley USA and rest America (6E05)
<b>Brand</b>	Bentley
<b>Transaction No.</b>	2067399/2
<b>Level</b>	EH
<b>Status</b>	Released for publishing
<b>Release date</b>	03-Nov-2022

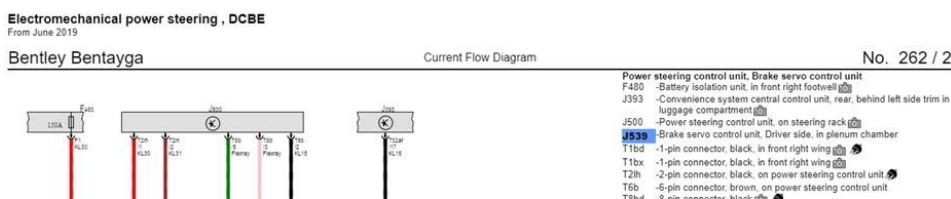
Figure 2

- 2) Referring to the applicable wiring diagram, Conduct an electrical integrity check of the plug connection for J539 (Figure 2) and associated circuits

- Referring to Rep.Gr97 - Conduct any applicable wiring repairs
