Technical product information

Topic	Bentayga Hybrid - Emission control system warning lamp illuminated within the DIP - Potential wiring clash condition
Market area	Bentley: worldwide (2WBE)
Brand	Bentley
Transaction No.	2065715/2
Level	EH
Status	Released for publishing
Release date	03-Nov-2022

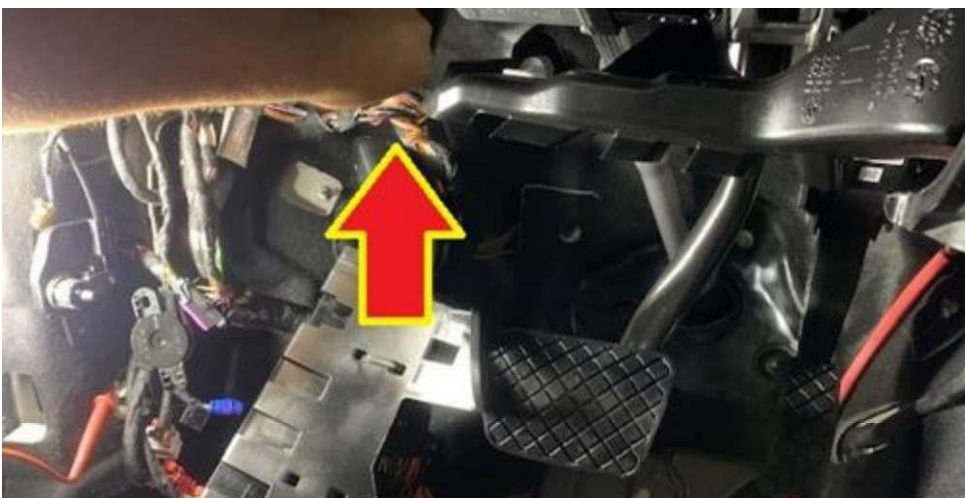
The issue described is evident on left hand drive vehicles only, in the event a similar issue is evident and the vehicle is right hand drive the operative should raise a DISS query and await feedback before conducting any further work

- Referring to the applicable Rep.Gr the operative should gain access to the location shown in Figure 2 (Underside of the dashboard left hand side)

- Check for damaged wiring/contact between the body/surrounding components and the wiring harness

NOTE: Please be aware the wiring harness can contact the body/surrounding components however the actual symptom(s) may be different depending on the wire(s) which are damaged/chaffed

1) Using the applicable wiring diagram, conduct wiring integrity checks to confirm the wire(s) which are damaged/chaffed

2) Referring to Rep.Gr97 - Repair the damaged wire(s)

3) Remove all sharp edges which could damage the main wiring harness

4) Reposition and secure the main wiring harness
