Technical Service Bulletin

57 Door handle touch sensor does not lock doors or is slow to respond

57 22 97 2067241/3 November 2, 2022. Supersedes Technical Service Bulletin Group 57 number 22-94 dated August 30, 2022, for reasons listed below.

Model(s)	Year	VIN Range	Vehicle-Specific Equipment
Q5 Sportback, and SQ5 Sportback	2022	All	Not Applicable
	2023	000001 - 035391

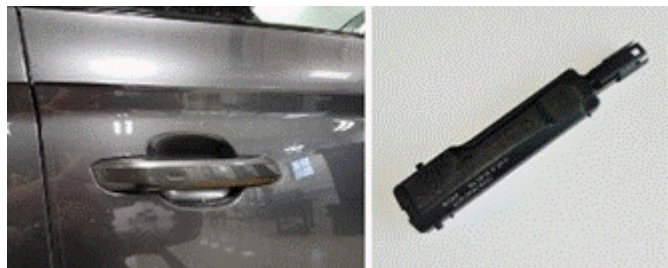
After exiting the vehicle, closing the door, and pressing the touch sensor on the exterior door handle the doors will either:

- Lock but only after a significant delay.

- Lock only after several attempts are made.
or
- Will not lock at all using the touch sensor.

Figure 1. Outer door handle and keyless locking touch sensor.

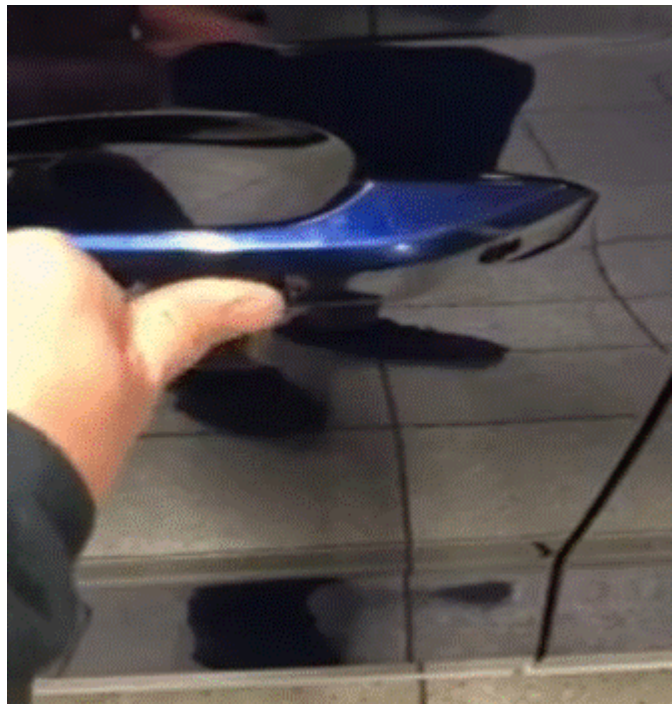
There are no relevant DTCs stored in the Comfort System Central Control Module (DA 0046, BCM 2). When the measuring values are checked during diagnosis the inoperative or delayed response in the lock command is clearly confirmed.

Figure 2. The locking system malfunctions while using the touch sensor.

An error has been identified in the door handle trim conductivity.

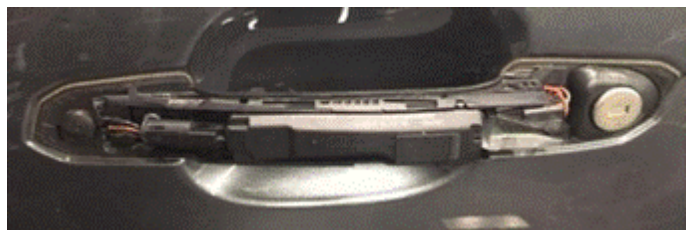
Figure 3. Exposed locking system touch sensor with door handle trim plate removed.

1. If the symptom profile is as described in this TSB and the measuring values confirm an inoperative or delayed response in the lock command, then remove the painted door handle trim plate of the affected door handle.

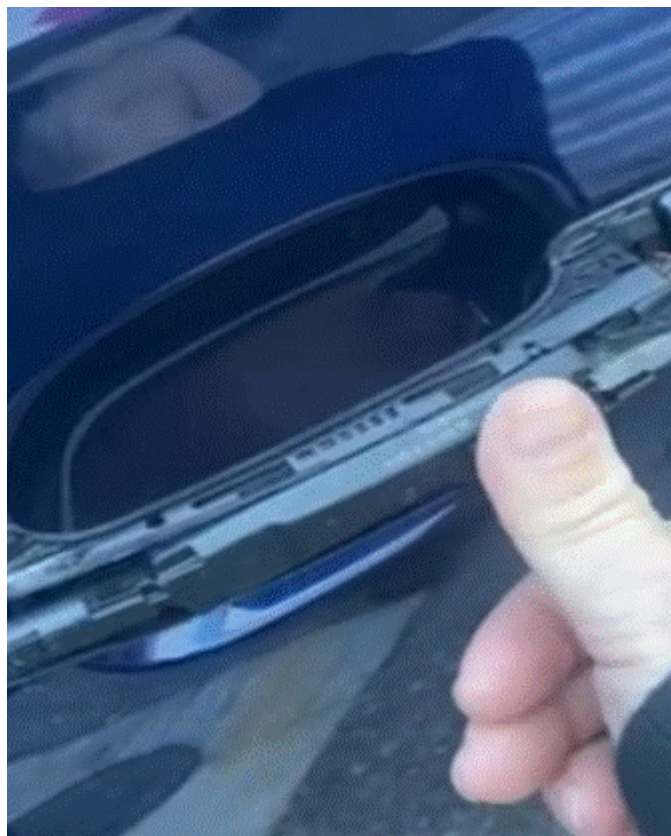
Figure 4. Activating the locking system touch sensor with door handle trim plate removed.

2. If the lock function works properly without the trim plate installed, then replace the door handle trim plate.
