# Technical product information

<b>Topic</b>	Bentayga and New Flying Spur Hybrid– DTC P103A00 evident – Engine Oil Fuel Portion Too High
<b>Market area</b>	Russische Föderation (5RU),Australia E04 Bentley rest Asia and Australia (6E04),China 796 VW Import Comp. Ltd (Vico), Beijing (6796),Germany E02 Bentley rest Europe (6E02),Japan E03 Bentley Japan (6E03),United Kingdom E01 Bentley UK (6E01),United States E05 Bentley USA and rest America (6E05)
<b>Brand</b>	Bentley
<b>Transaction No.</b>	2062365/3
<b>Level</b>	EH
<b>Status</b>	Released for publishing
<b>Release date</b>	04-Nov-2022

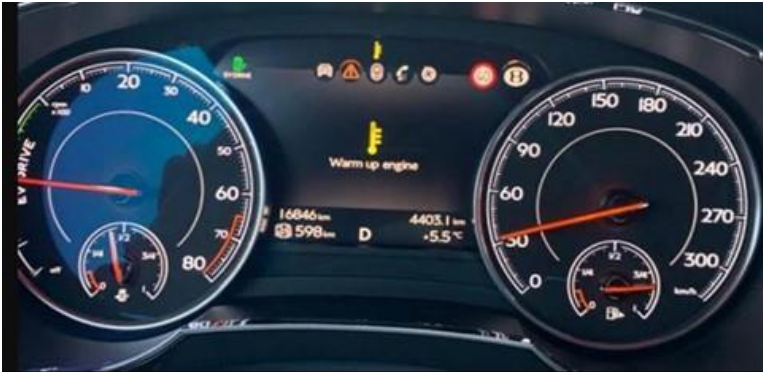
Figure 1

- Warning message within the DIP
- The message asks the customer to 'warm up engine' accompanied by a yellow warning (Figure 1) No other symptoms are experienced.

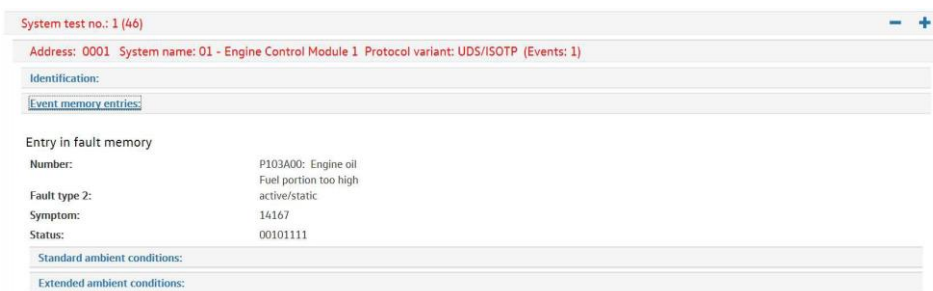
Figure 2

- DTC P103A00 evident - Engine Oil Fuel Portion Too High (Figure 2)

The warning is caused by the level of unburnt fuel in the engine oil. This value is calculated by the Engine Control Module (ECM) and is based on the driver usage pattern

The more cold starts the Internal Combustion Engine (ICE) is exposed to the higher the chance of fuel making its way into the engine oil via the cylinders

When the fuel calculation reaches the pre-programmed amount this then causes the DTC to be triggered

Using ODIS – Navigate and read the following values:

- IDE10063 – Engine oil current value *NOTE: Must be 100% or less other wise the DTC cannot be deleted*
- IDE04820 - Total mass of gasoline and alcohol in the oil (Level of fuel within the engine oil - Calculated by the ECM) *NOTE: If the value is larger than > 250 grams, the error cannot be deleted.*

2) Referring to the Rep.Gr 17- Check the engine oil level *NOTE: Ensure the method within Rep.Gr 17 is followed*

- **IMPORTANT:** In the event the engine oil level is deemed as excessively high, the oil level should be reduced/corrected - Refer to Rep.Gr 17 - Drain the required amount of engine oil to adjust the oil level to specification

3) Drive the vehicle in SPORT mode for 30 KM (Observing all local speed limits) with enthusiastic driving to reduce the fuel MWB value (IDE04820) to less than 50 grams

In the event the MWB value (IDE04820) cannot be reduced lower than 50 grams, please raise a DISS query and await further instruction prior to conducting any further work

- In the event the MWB value (IDE04820) has been successfully reduced (Lower than 50 grams) Erase the applicable DTC's

4) Referring to Rep.Gr 17- Check the engine oil level is correct post road test to confirm any evaporated fuel has not reduced the oil level
