Revision: J Range of applicable VINs updated 09/23/2022

P20EE (diagnostic troubleshooting code) SOLUTION - NOX CONVERSION EFFICIENCY
 Prevost vehicles

B13R (9700 us/can)

GHG17 or OBD18 compliant vehicles

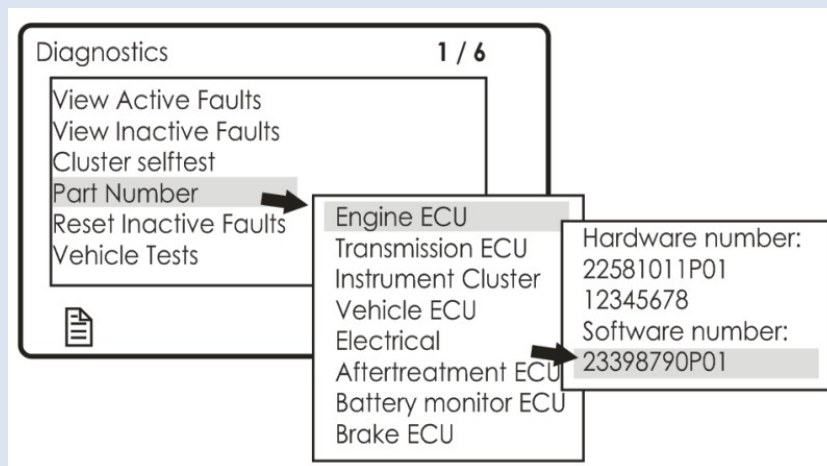
4 Check and record the engine ECU (a.k.a. Engine Control Module ECM) software number.
To do so, check in the dashboard DID. Select DIAGNOSTICS > PART NUMBER > ENGINE ECU

If the engine ECU software is not up to date, perform an update to the latest version (software version should be 23766686 or higher).

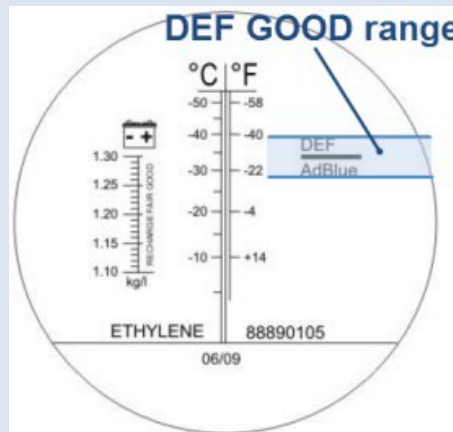
Apply a drop of DEF on the viewer of the refractometer. If the level is above the word "DEF" or below the word "AdBlue" the DEF is contaminated. If no level is shown, it may indicate chemical residue, such as pure water or diesel fuel.

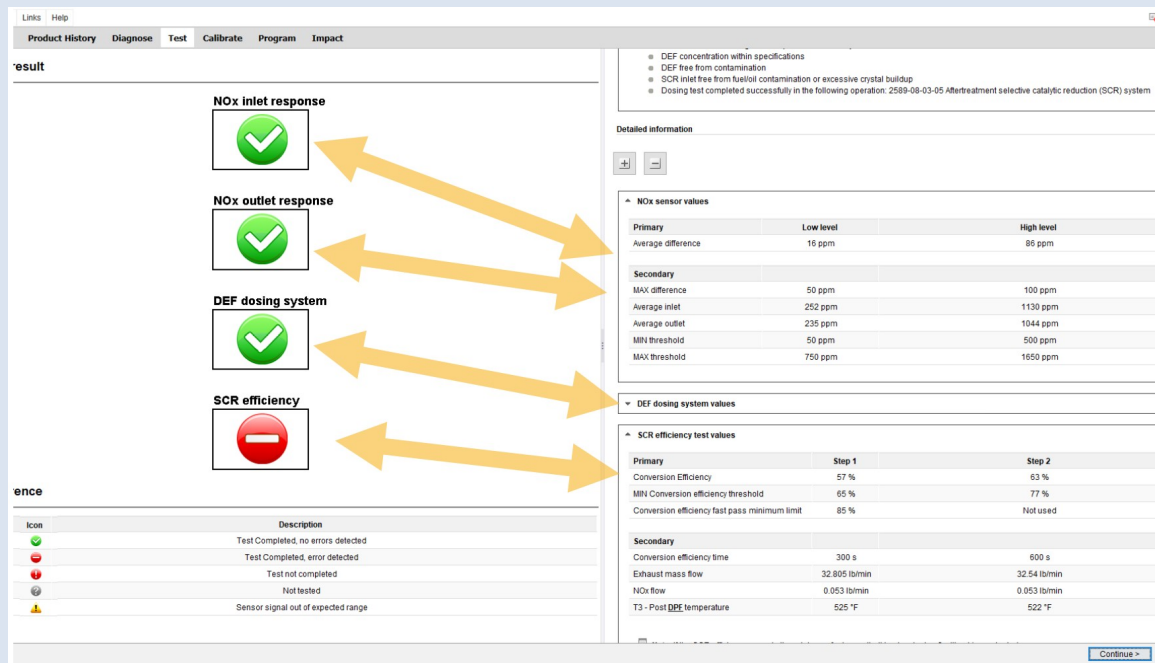
Take a screen capture of the Test result (image below) and save for submittal.
