Technical product information

Topic	DTC P1B8100 stored within 006B – Aerodynamic control unit - No test plan in ODIS to assist with diagnosis
Market area	Russische Föderation (5RU),Australia E04 Bentley rest Asia and Australia (6E04),China 796 VW Import Comp. Ltd (Vico), Beijing (6796),Germany E02 Bentley rest Europe (6E02),Japan E03 Bentley Japan (6E03),Korea, (South) E08 Bentley South Korea (6E08),United Arab Emirates E06 Bentley Middle East and Africa (6E06),United Kingdom E01 Bentley UK (6E01),United States E05 Bentley USA and rest America (6E05)
Brand	Bentley
Transaction No.	2068151/2
Level	EH
Status	Released for publishing
Release date	07-Nov-2022

New Continental GT

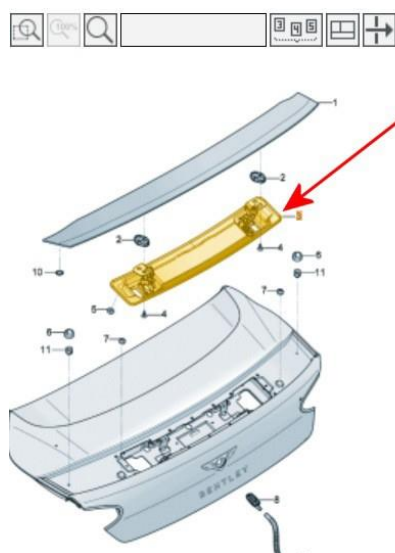
Figure 1

Refer to the ETKA parts catalogue for the deployable rear spoiler assembly (lifting platform as Figure 1) part number

- Should no wiring issues be evident - Referring to Rep.Gr 66 replace the deployable rear spoiler assembly
