# **Technical product information**

Торіс	New Continental GT and GTC - Window drop glass concerns
Market area	Russische Föderation (5RU),Australia E04 Bentley rest Asia and Australia (6E04),China 796 VW Import Comp. Ltd (Vico), Beijing (6796),Germany E02 Bentley rest Europe (6E02),Japan E03 Bentley Japan (6E03),Korea, (South) E08 Bentley South Korea (6E08),United Arab Emirates E06 Bentley Middle East and Africa (6E06),United Kingdom E01 Bentley UK (6E01),United States E05 Bentley USA and rest America (6E05)
Brand	Bentley
Transaction No.	2067436/5
Level	EH
Status	Released for publishing
Release date	04-Nov-2022

## **New Continental GT and GTC**

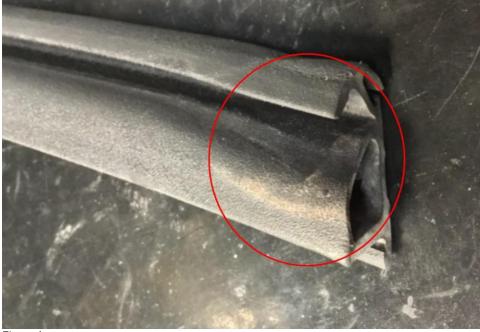
- Damage
- Splits
- Tears
- Misalignment
- Incorrectly fitted/located
- Drop glass seal deformation (see Figures 4 and 5 as examples)

NOTE: Any issues found with the window seals <u>must</u> be rectified before conducting the remaining steps 6) Referring to Rep.Gr 64 - Check the front and rear window regulators are fitted to specification
