Technical product information

Topic	Secondary air injection - Missing ODIS data
Market area	Russische Föderation (5RU),Australia E04 Bentley rest Asia and Australia (6E04),China 796 VW Import Comp. Ltd (Vico), Beijing (6796),Germany E02 Bentley rest Europe (6E02),Japan E03 Bentley Japan (6E03),Korea, (South) E08 Bentley South Korea (6E08),United Arab Emirates E06 Bentley Middle East and Africa (6E06),United Kingdom E01 Bentley UK (6E01),United States E05 Bentley USA and rest America (6E05)
Brand	Bentley
Transaction No.	2061064/2
Level	EH
Status	Released for publishing
Release date	04-Nov-2022

New Continental GT - GTC and New Flying Spur

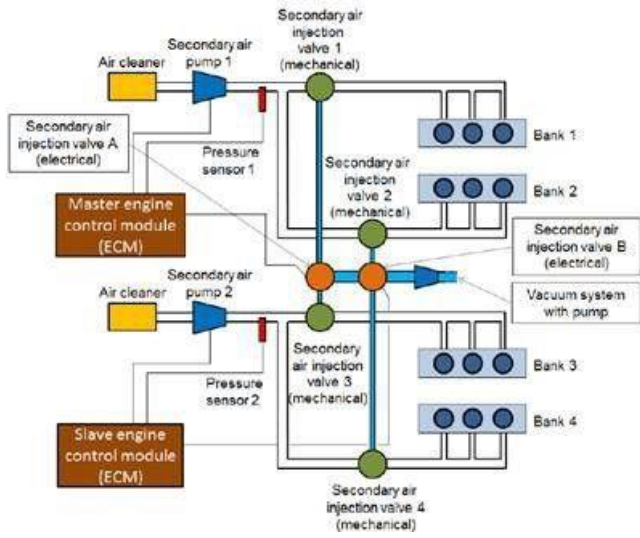
- Figure 3 shows the layout of the secondary air injection system
