# Technical product information

<b>Topic</b>	Electronic Parking Brake (EPB) functionality issues
<b>Market area</b>	Russische Föderation (5RU),Australia E04 Bentley rest Asia and Australia (6E04),China 796 VW Import Comp. Ltd (Vico), Beijing (6796),Germany E02 Bentley rest Europe (6E02),Japan E03 Bentley Japan (6E03),Korea, (South) E08 Bentley South Korea (6E08),United Arab Emirates E06 Bentley Middle East and Africa (6E06),United Kingdom E01 Bentley UK (6E01),United States E05 Bentley USA and rest America (6E05)
<b>Brand</b>	Bentley
<b>Transaction No.</b>	2062184/7
<b>Level</b>	EH
<b>Status</b>	Released for publishing
<b>Release date</b>	04-Nov-2022

## New Continental GT/GTC and New Flying Spur

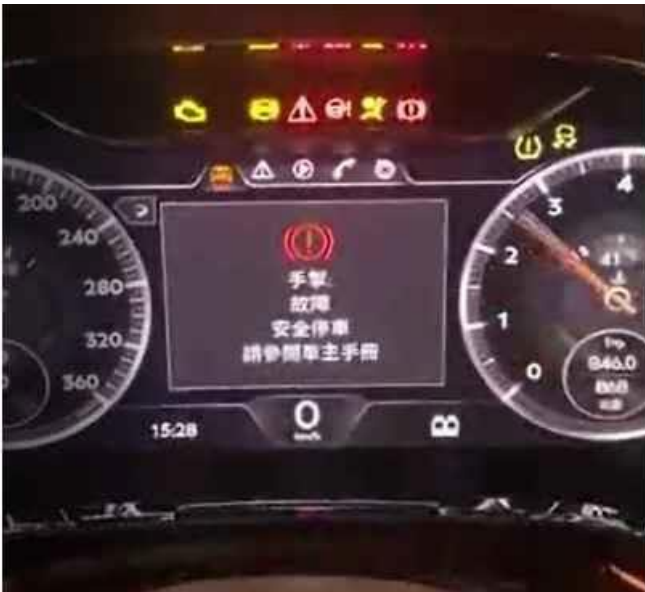
Figure 1

- Electronic Parking Brake (EPB) found not operating to specification
- EPB may not hold the car effectively
- Parking brake components showing signs of wear
- Parking brake warning light may also be evident within the DIP (See example shown in Figure 1)

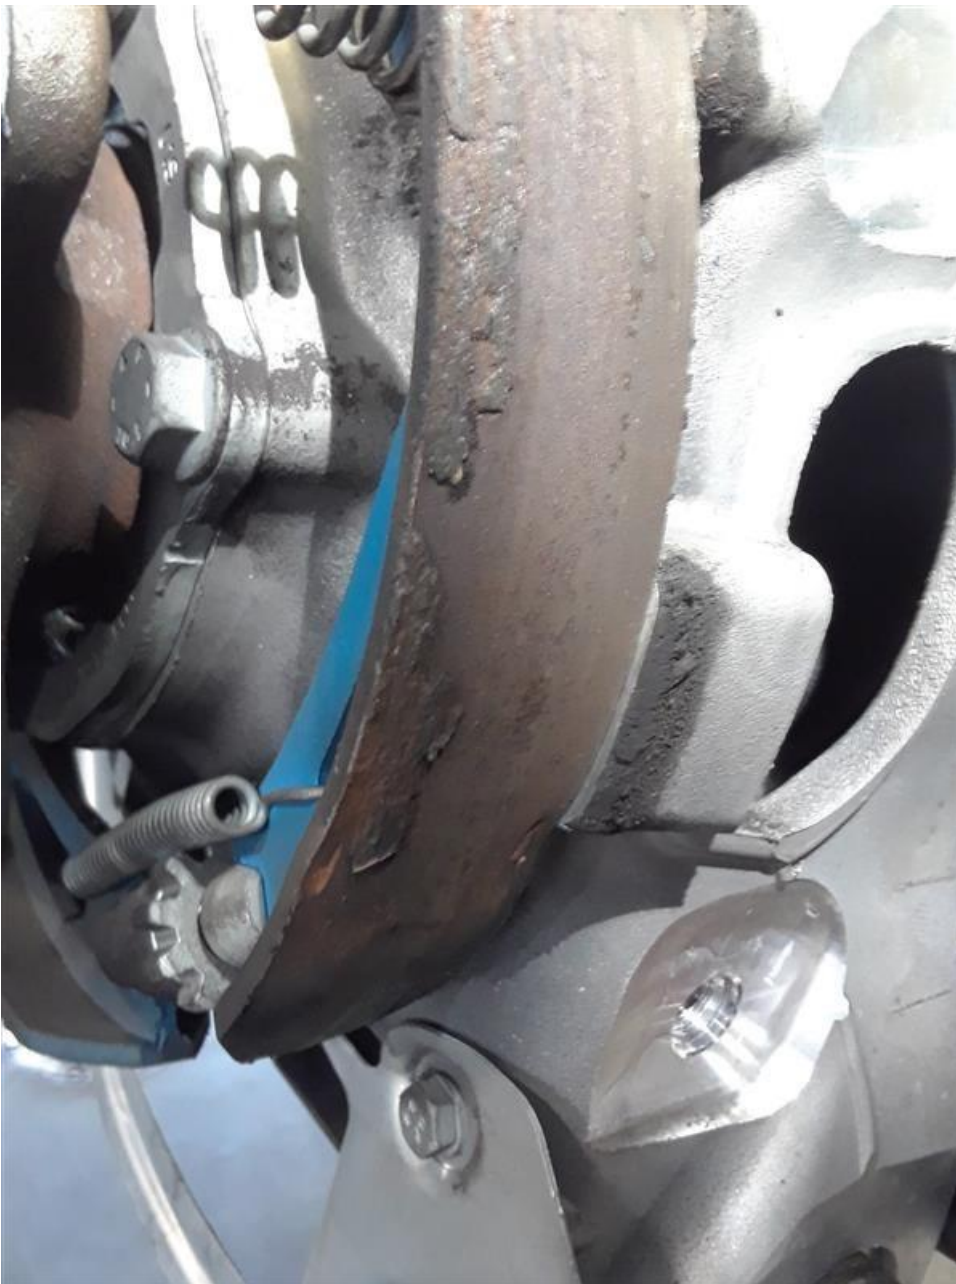
- Right and left hand (EPB) Actuators
- Right and left hand rear brake shoes (EPB) - See example shown in Figure 2

1) Carry out a full inspection of the (Electronic Parking Brake EPB) system including the following components:

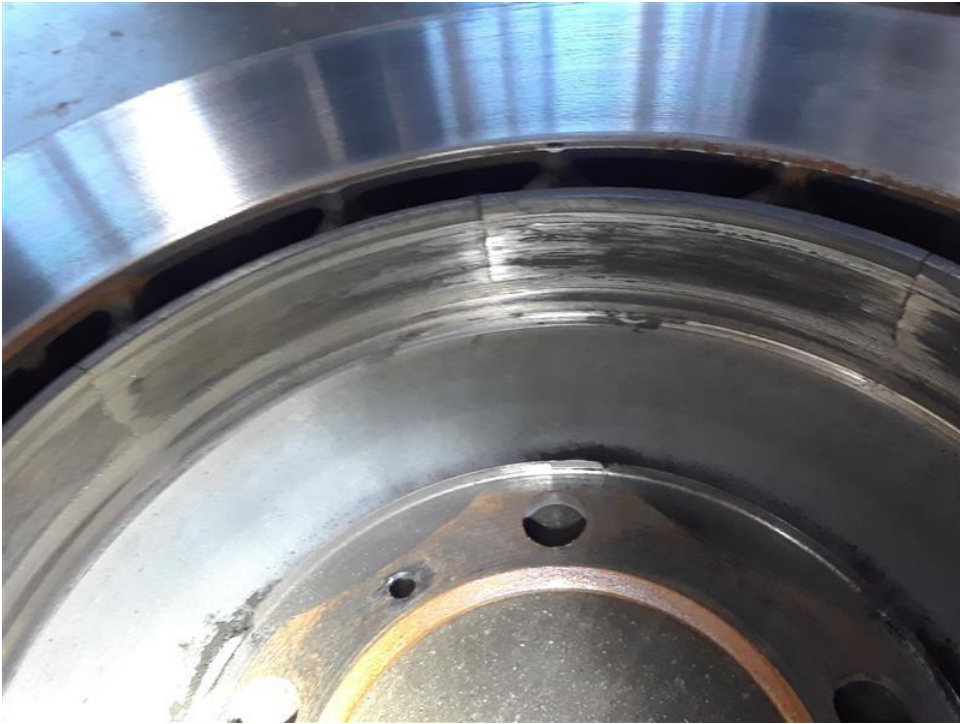
- Right and left hand rear brake discs - See example shown in Figure 3
