Technical product information

Topic	New Continental GT / GTC and New Flying Spur - Exhaust Flap - Diagnostic Trouble Code
Market area	Russische Föderation (5RU),Australia E04 Bentley rest Asia and Australia (6E04),China 796 VW Import Comp. Ltd (Vico), Beijing (6796),Germany E02 Bentley rest Europe (6E02),Japan E03 Bentley Japan (6E03),Korea, (South) E08 Bentley South Korea (6E08),United Arab Emirates E06 Bentley Middle East and Africa (6E06),United Kingdom E01 Bentley UK (6E01),United States E05 Bentley USA and rest America (6E05)
Brand	Bentley
Transaction No.	2060432/4
Level	EH
Status	Released for publishing
Release date	04-Nov-2022

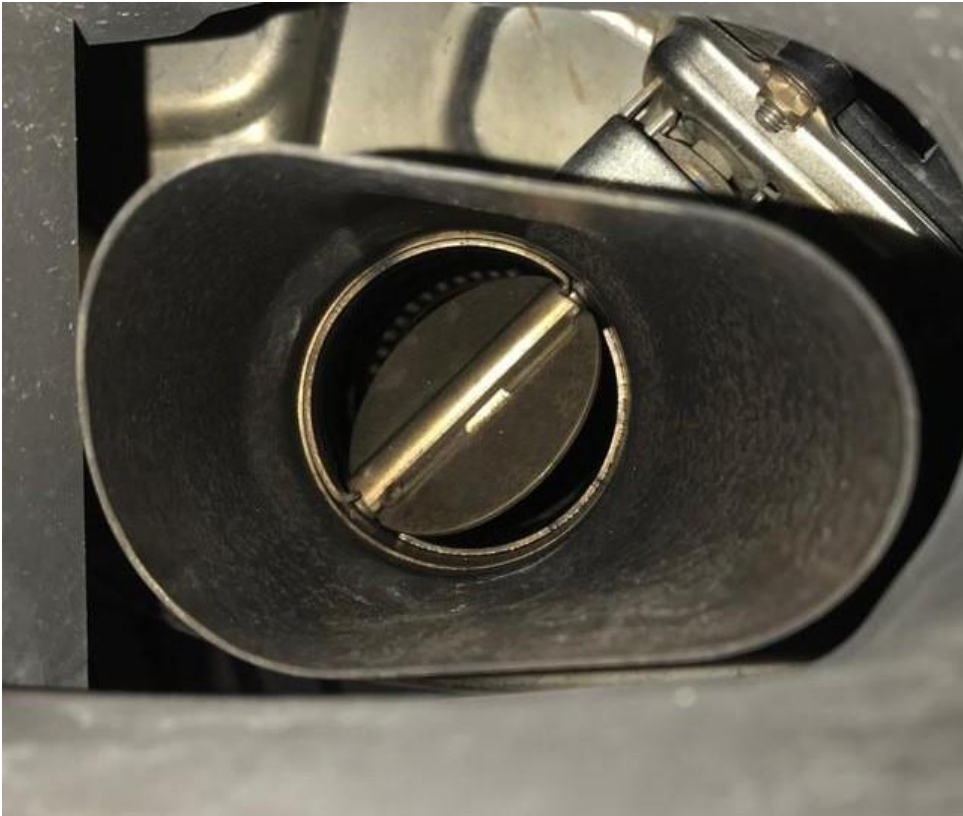
Figure 1.

The root cause of Exhaust Flap Control Unit malfunction is electrical 'shorting' of the commutator segments, this is caused by an accumulation of "Sludge" within the Control Unit. A DTC is stored when the respective Control Unit does not move through its full range of motion.

If an Exhaust Flap is stuck in an open, closed, partially closed position or does not achieve a full range of motion continue to follow the instructions within this Technical Product Information (TPI) document—figure 1.

Remove the suspected Exhaust Flap Control Unit – Refer to *Repair Group. 26 Exhaust system – Exhaust flap control units (J883, 945) – To remove and fit.*

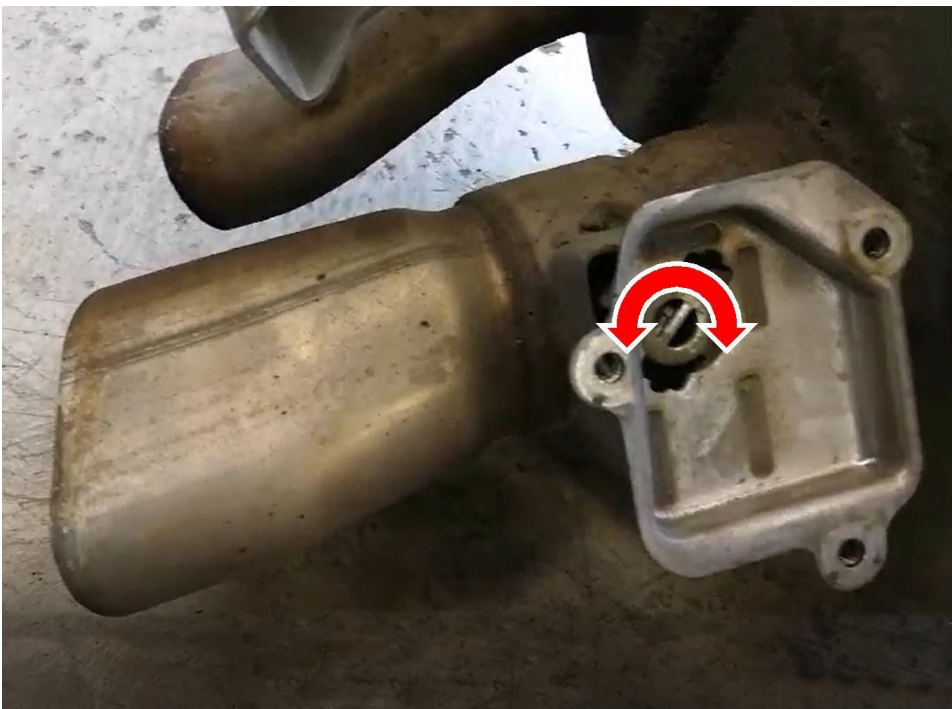
Check and confirm the Exhaust Flap spindle is free to open and close by hand - Figure 2.

If no issue is evident and the Exhaust Flap oscillates freely by hand - replace the defective Exhaust Flap Control Unit, refer to *Repair Group. 26 Exhaust system – Exhaust flap control units (J883, 945) – To remove and fit.*
