# Technical product information

<b>Topic</b>	Knocking noise from the front and/or rear (Driving over an uneven road surface)
<b>Market area</b>	Russische Föderation (5RU),Australia E04 Bentley rest Asia and Australia (6E04),China 796 VW Import Comp. Ltd (Vico), Beijing (6796),Germany E02 Bentley rest Europe (6E02),Japan E03 Bentley Japan (6E03),Korea, (South) E08 Bentley South Korea (6E08),United Arab Emirates E06 Bentley Middle East and Africa (6E06),United Kingdom E01 Bentley UK (6E01),United States E05 Bentley USA and rest America (6E05)
<b>Brand</b>	Bentley
<b>Transaction No.</b>	2064791/2
<b>Level</b>	EH
<b>Status</b>	Released for publishing
<b>Release date</b>	04-Nov-2022

Knocking noise from the underside of the vehicle (front and/or rear) when driving on uneven road surfaces

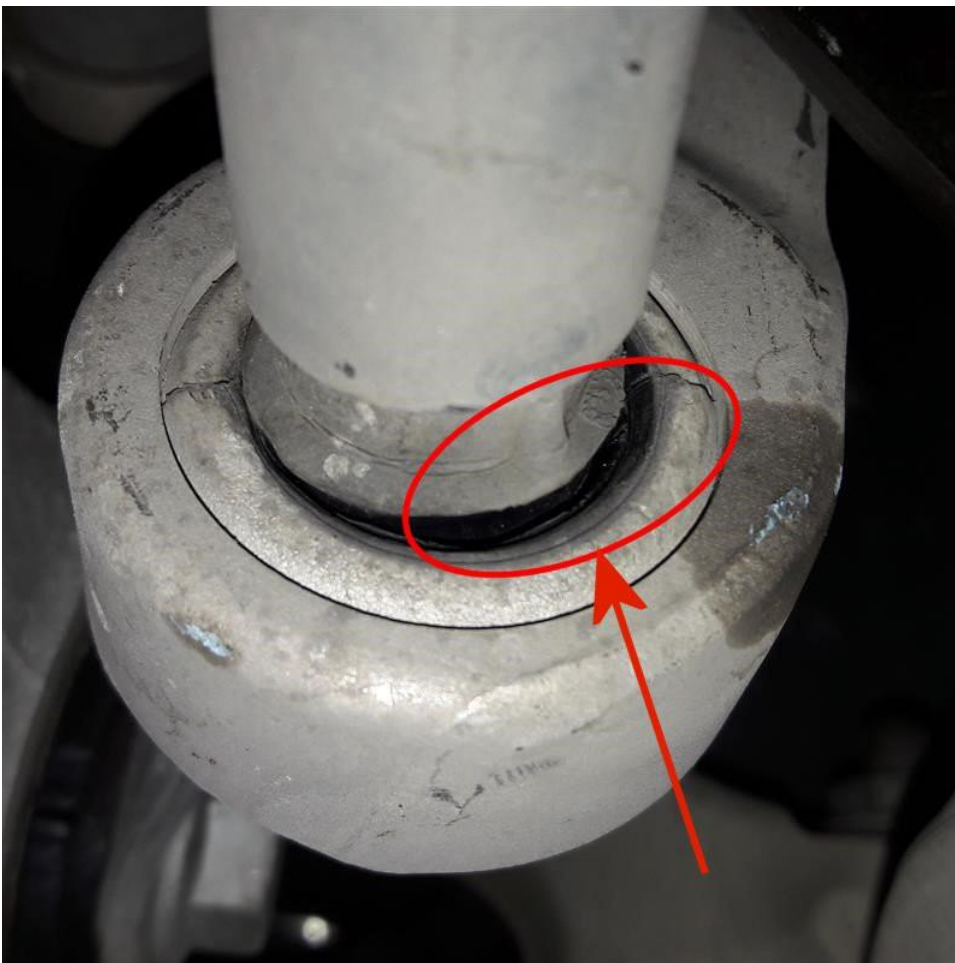
Figure 1

The noise present in the sound file can be caused by worn anti roll bar bushes, the noise can appear when driving over an uneven road surface or during a large suspension input for example:

- Worn front and/or rear anti-roll bar drop link bushes (Figure 1)

- 3) Conduct a full inspection of the anti roll bar and surrounding components
- 4) Raise a DISS query ensuring any photos and videos are attached of the issues found NOTE: The operative does not have to wait for a response before replacing parts, the required parts should be replaced as detailed in step 5
- 5) Referring to the applicable Rep.Gr - Replace the left and right drop links (front and/or rear)

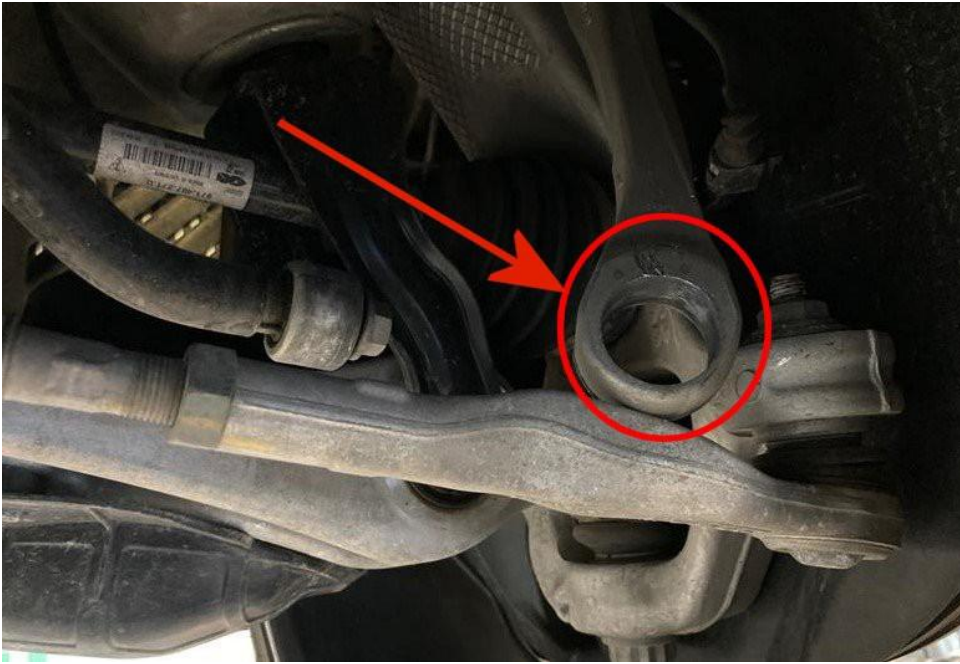
Figure 2

2) Check the front and/or rear anti roll bar drop link has not detached (Figure 2) in this scenario DTC (C1298F1: Suspension stabilization actuator Regulation not possible) may also be evident within address D4 and/or D5
