# Technical product information

<b>Topic</b>	Knocking noise from the front and/or rear - DTC C1298F1 evident within D4 and/or D5
<b>Market area</b>	Russische Föderation (5RU),Australia E04 Bentley rest Asia and Australia (6E04),China 796 VW Import Comp. Ltd (Vico), Beijing (6796),Germany E02 Bentley rest Europe (6E02),Japan E03 Bentley Japan (6E03),Korea, (South) E08 Bentley South Korea (6E08),United Arab Emirates E06 Bentley Middle East and Africa (6E06),United Kingdom E01 Bentley UK (6E01),United States E05 Bentley USA and rest America (6E05)
<b>Brand</b>	Bentley
<b>Transaction No.</b>	2065085/2
<b>Level</b>	EH
<b>Status</b>	Released for publishing
<b>Release date</b>	04-Nov-2022

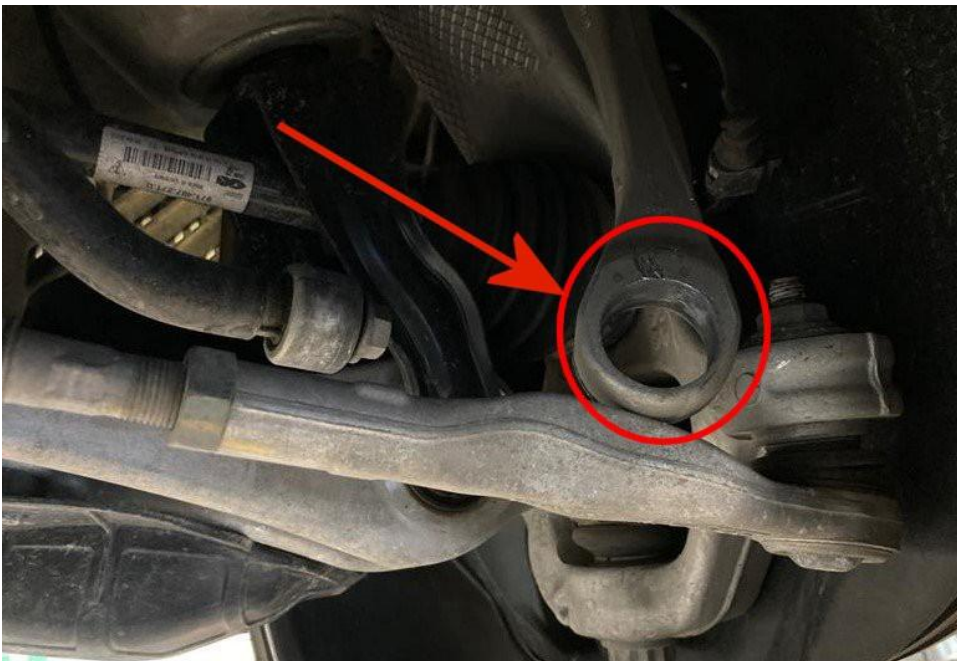
Figure 1

- Knocking noise from the underside of the vehicle (front and/or rear) when driving on uneven road surfaces
- DTCC1298F1 (Suspension stabilization actuator Regulation not possible) evident within diagnostic address D4 and/or D5
- Bentley Dynamic ride fault evident within the DIP

NOTE: The photo shown within this TPI is of the front anti roll bar drop link, please note the issue can also be evident on the rear

1) Check the front and/or rear anti roll bar drop link has not detached (Figure 1) in this scenario DTC (C1298F1: Suspension stabilization actuator Regulation not possible) may be evident within address D4 and/or D5

3) Raise a DISS query ensuring any photos and videos are attached of the issues found NOTE: The operative does not have to wait for a response before replacing parts - Referring to the applicable Rep.Gr - Replace the applicable drop link
