Technical product information

Topic	Repeated traction control interventions experienced upon reaching 30km/h
Market area	Bentley: worldwide (2WBE)
Brand	Bentley
Transaction No.	2067579/2
Level	EH
Status	Released for publishing
Release date	04-Nov-2022

New Continental GT(C) and New Flying Spur

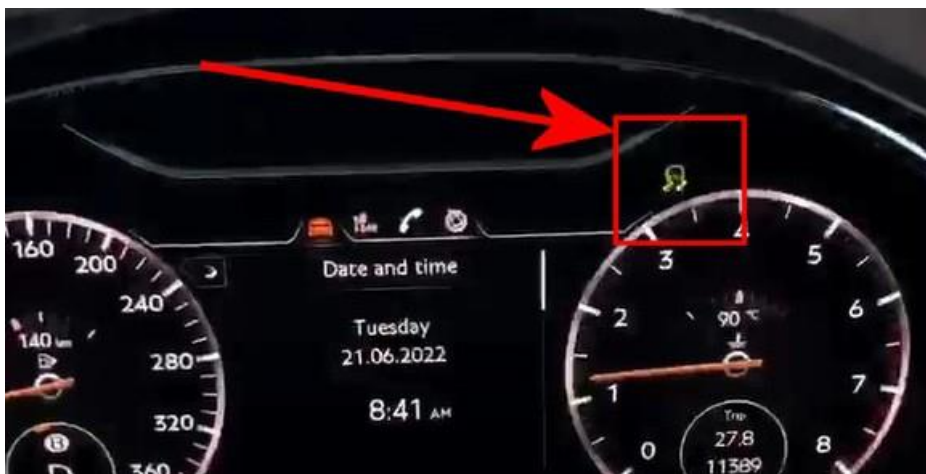
Figure 1

Repeated traction control interventions experienced upon reaching 30km/h (Figure 1)

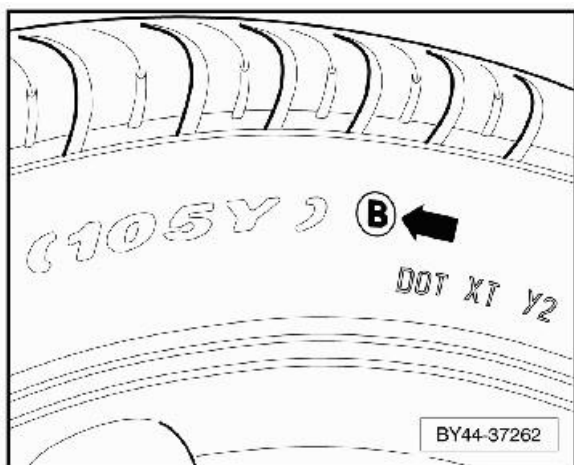
Figure 2

- Confirm the 'B' marking is evident on all tyres (Figure 2)
