Technical product information

Topic	"Drive System Fault" warning present within the DIP - Under full throttle conditions
Market area	Russische Föderation (5RU),Australia E04 Bentley rest Asia and Australia (6E04),China 796 VW Import Comp. Ltd (Vico), Beijing (6796),Germany E02 Bentley rest Europe (6E02),Japan E03 Bentley Japan (6E03),Korea, (South) E08 Bentley South Korea (6E08),United Arab Emirates E06 Bentley Middle East and Africa (6E06),United Kingdom E01 Bentley UK (6E01),United States E05 Bentley USA and rest America (6E05)
Brand	Bentley
Transaction No.	2067483/3
Level	EH
Status	Released for publishing
Release date	04-Nov-2022

New Continental GT(C) and New Flying Spur - V8 Kovomo

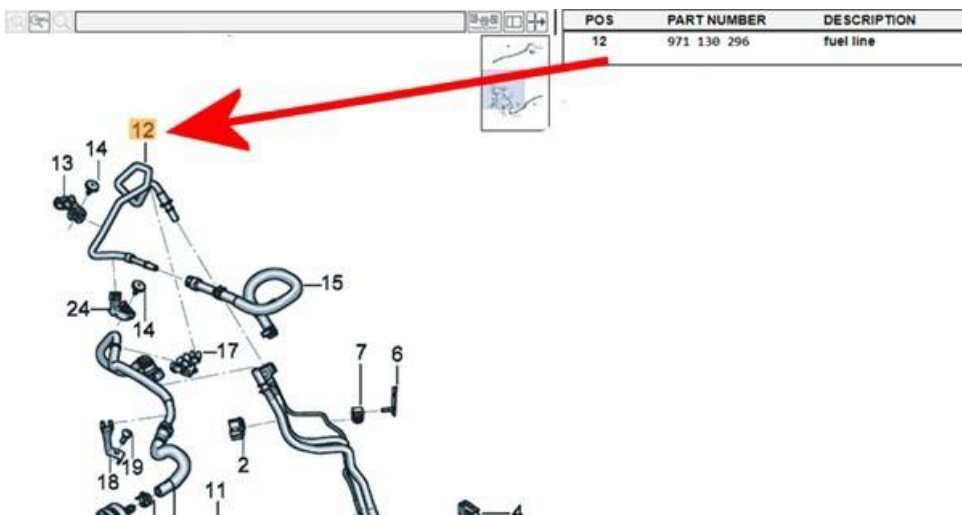
3) Referring to Figure 2 (Item 12) remove the fuel line shown

- In the event the fuel line is blocked/restricted - Replace the fuel line as shown in Figure 2 (item 12) ensuring all Rep.Gr guidelines are strictly adhered to

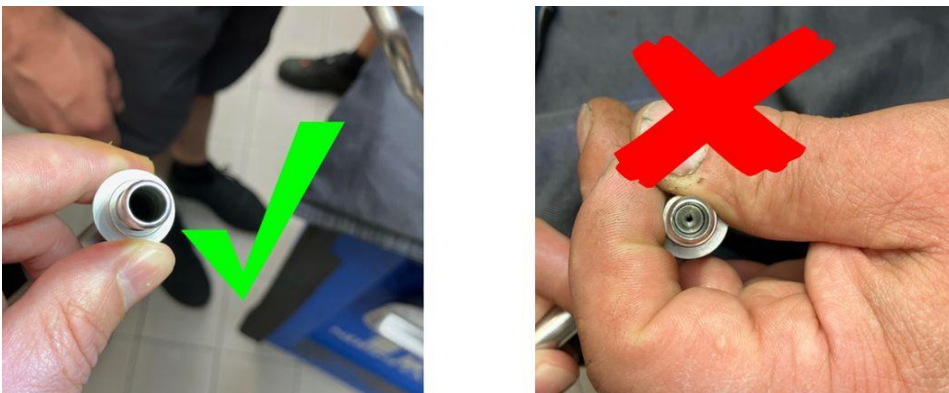
4) Referring to Figure 3 - Check to confirm if the fuel line is blocked/restricted

- In the event the fuel line is not blocked/restricted the operative should refer to Rep.Gr 20 and conduct the Low pressure fuel system - to test and provide feedback via a new or existing DISS query
