Technical product information

| Topic | Various and/or numerous Transmission control module DTC's logged - V8 Kovomo engine |
| Brand | Bentley |

New Continental GT/GTC - New Flying Spur - V8 Kovomo

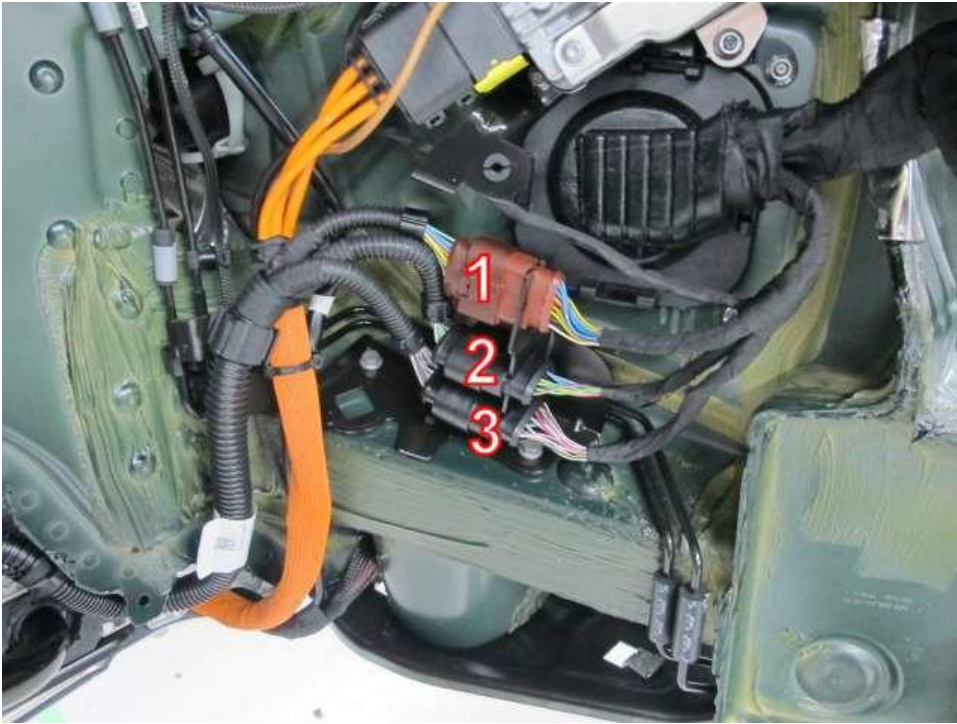
Loose pins within the transmission link harness to the Mechatronic unit for dual clutch gearbox -J743- connections can lead to various and/or numerous Transmission control module DTC's being logged

- Referring to Figure 2 - Disconnect the three connectors shown

2) Once disconnected carry out pin/terminal grab checks on all three male and female connections

- In the event the main vehicle harness pins are not to specification the applicable pins should be replaced
- Should any issues be found with the transmission link harness and/or pins – the harness should be replaced
- **IMPORTANT NOTE:** In the event the pins are to specification or the applicable repairs have been done (for example - Harness replacement or pin replacement) - Reconnect all three connectors (Figure 2) and proceed to Step 3
