Front Passenger Footwell And/Or Glove Compartment With Increased Temperature

Topic number	LI83.20-P-075513
Version	1
Function group	83.20 - Heating
Date	11/7/22
Validity	Valid for all vehicles of model series 232
Reason for change

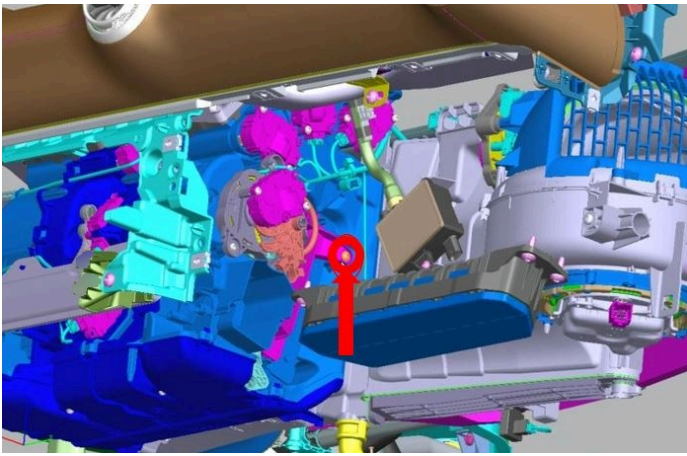
Attachments	
File	Description
Schraubverbindung_Auffangwanne.JPG	"Threaded connection"

Missing or loose threaded connection at collecting pan (A2068310000) - see picture "Threaded connection"

Remove glove compartment housing (ar68.10-p-1400sly) and check threaded connection (see picture 1).

If screw N000000008345 is missing or the threaded connection is loose, retrofit/rework accordingly.
