Technical product information

Topic	DTC's P014800 and/or P008A00 - Rough running & potentially poor start up performance - MIL light on - Possible misfires
Market area	Russische Föderation (5RU),Australia E04 Bentley rest Asia and Australia (6E04),China 796 VW Import Comp. Ltd (Vico), Beijing (6796),Germany E02 Bentley rest Europe (6E02),Japan E03 Bentley Japan (6E03),Korea, (South) E08 Bentley South Korea (6E08),United Arab Emirates E06 Bentley Middle East and Africa (6E06),United Kingdom E01 Bentley UK (6E01),United States E05 Bentley USA and rest America (6E05)
Brand	Bentley
Transaction No.	2062016/4
Level	EH
Status	Released for publishing
Release date	09-Nov-2022

New Continental GT/GTC and New Flying Spur - W12 TSI only

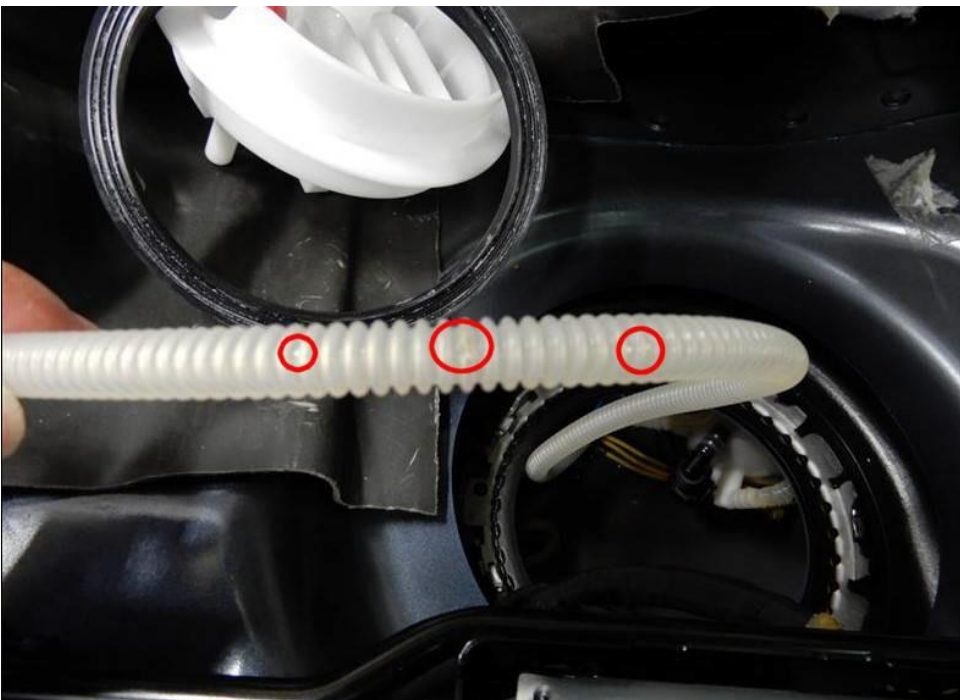
- Damage
 - Kinking of the fuel lines
 - Leakage
8. Should no issues be found - Refer to Rep.Gr 20 - Gain access to the Fuel pump within the fuel tank
- Inspect the Fuel supply module and fuel filter fitment for detached hoses, damaged hoses and line and/or concerns with the module itself such as damage or leakage
 - Figure 1 shows an example of a fuel tank internal hose with pin holes (circled)

9. Should any of the afore mentioned issues be evident the required parts should be replaced as necessary. However in the event that all previous checks were to specification the operative should conduct step 10 to completion.

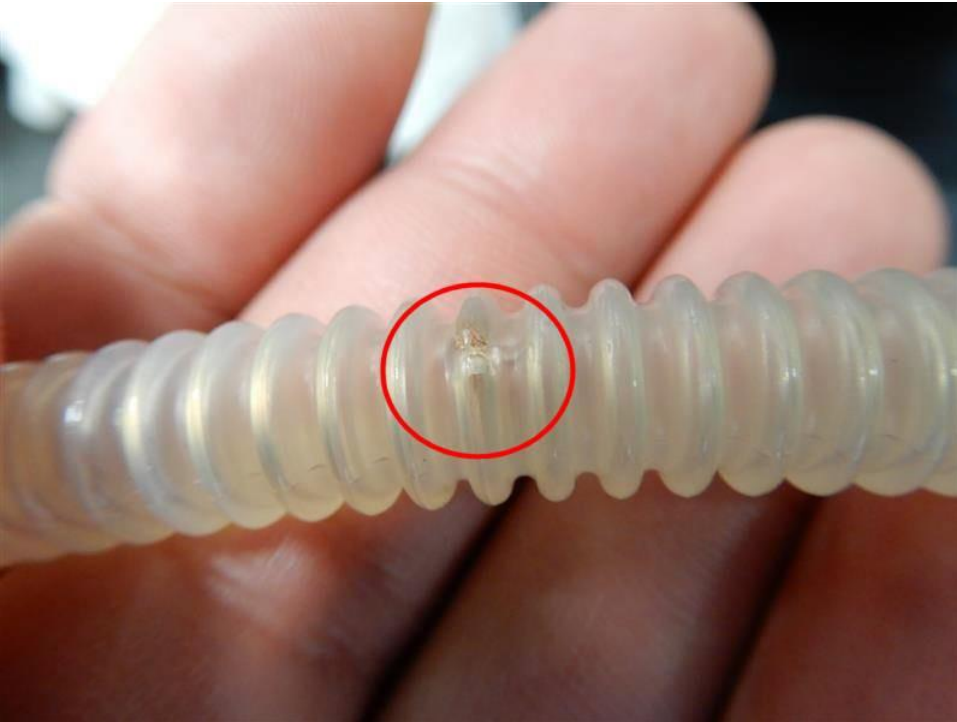
- Figure 2 shows a close up of the pin holes
