Technical product information

Topic	Engine coolant - Overheat condition - Warning evident within the DIP - DTC's P2B6500 and P2B8600 are evident
Market area	Russische Föderation (5RU),Australia E04 Bentley rest Asia and Australia (6E04),China 796 VW Import Comp. Ltd (Vico), Beijing (6796),Germany E02 Bentley rest Europe (6E02),Japan E03 Bentley Japan (6E03),Korea, (South) E08 Bentley South Korea (6E08),United Arab Emirates E06 Bentley Middle East and Africa (6E06),United Kingdom E01 Bentley UK (6E01),United States E05 Bentley USA and rest America (6E05)
Brand	Bentley
Transaction No.	2066669/2
Level	EH
Status	Released for publishing
Release date	07-Nov-2022

W12 - New Continental GT/GTC & New Flying Spur

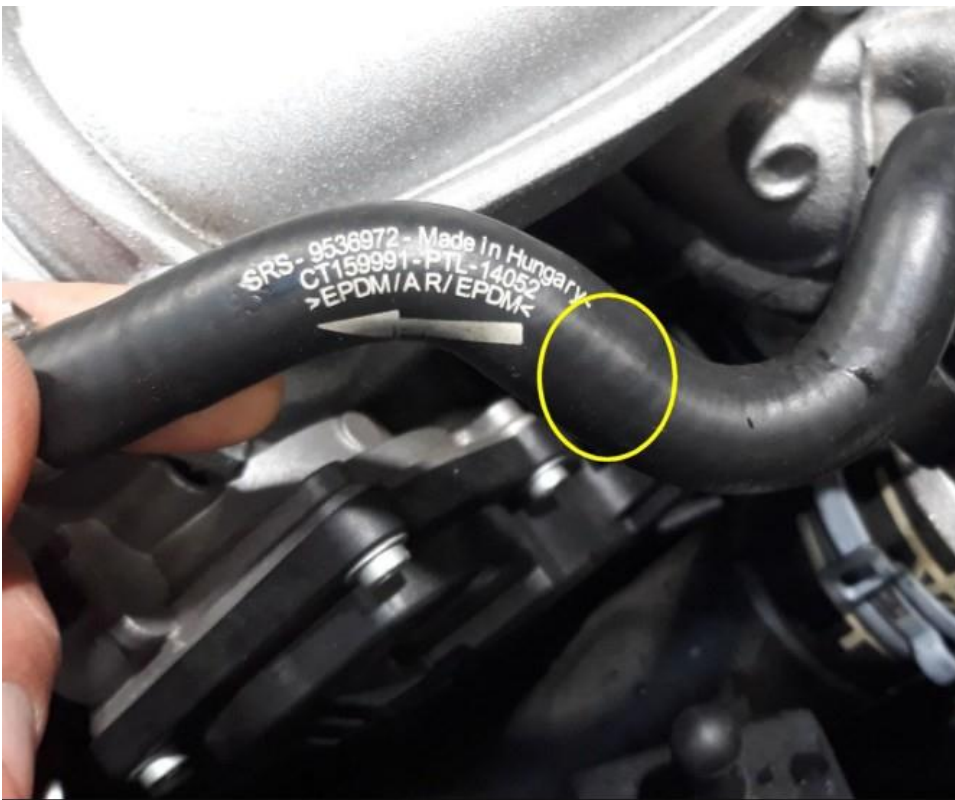
- The vent hose has an internal check valve, the valve is positioned within the vent hose at the location shown in Figure 3 (Circled)

4) Replace the vent line

- Once the vent line has been replaced - Referring to Rep.Gr 19 - Bleed the coolant system
- Erase all applicable DTC's
- Conduct a road test - On return check to confirm that no coolant related DTC's are evident

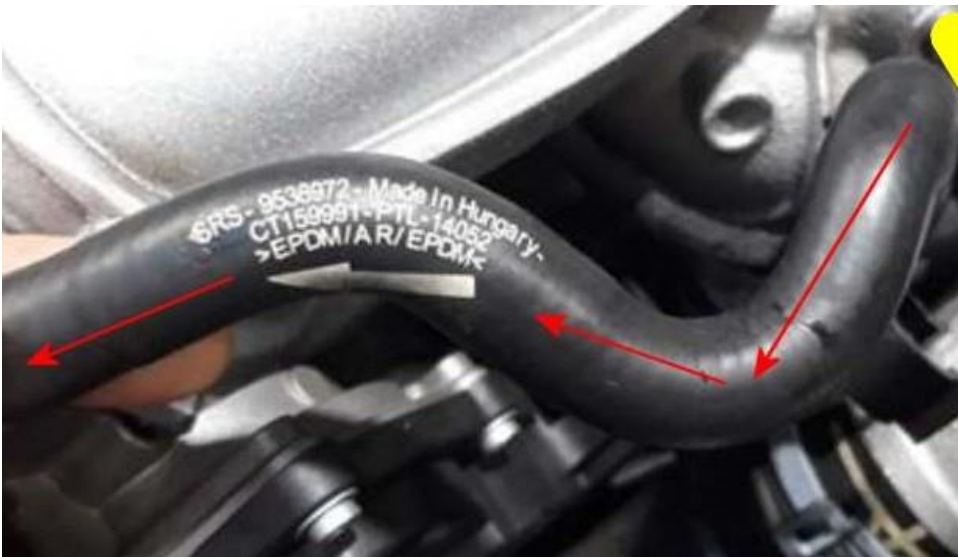
- Referring to Figure 4 - The coolant flows in the direction shown (Arrows) in the event the internal check valve is faulty the flow of the coolant will be restricted (Causing the symptoms described within the customer findings/workshop findings section)

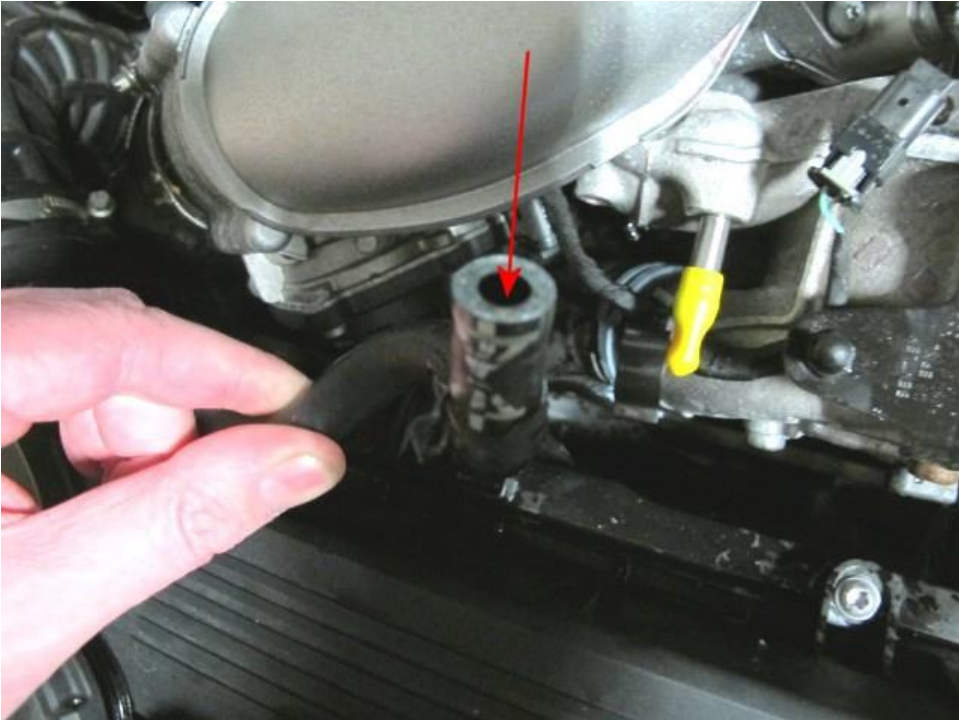
Does the air flow through the vent line without any restrictions? No

5) Referring to Figure 8 - Apply light air pressure into hose (Arrow)
