## Technical product information

<b>Topic</b>	Transmission communication DTC's (Numerous) - W12 engine
<b>Market area</b>	Bentley: worldwide (2WBE)
<b>Brand</b>	Bentley
<b>Transaction No.</b>	2059068/5
<b>Level</b>	EH
<b>Status</b>	Released for publishing
<b>Release date</b>	07-Nov-2022

### New Continental GT/C and New Flying Spur - W12 engine

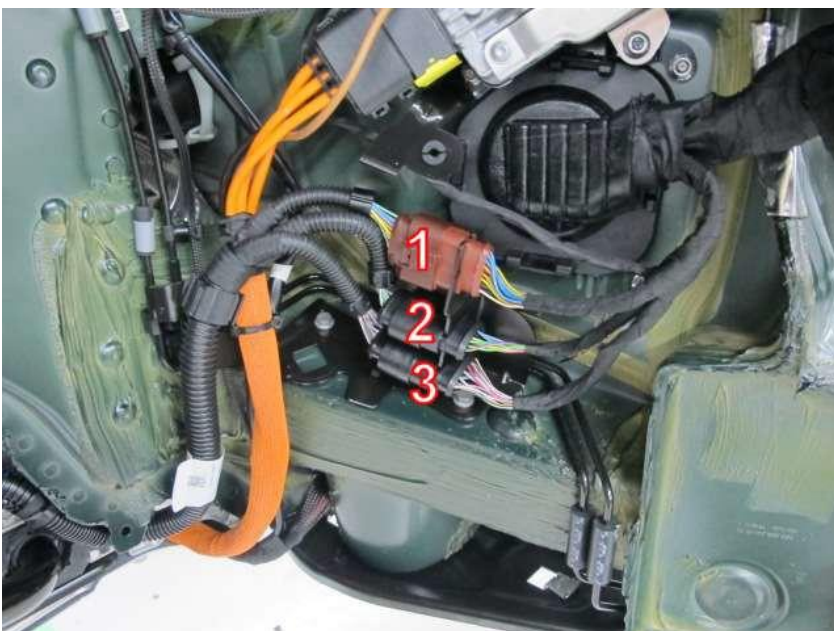
- Referring to Figure 2 - Disconnect the three connectors shown

2) Once disconnected carry out pin/terminal grab checks on all three male and female connections

- In the event the main vehicle harness pins are not to specification the applicable pins should be replaced
- Should any issues be found with the transmission link harness and/or pins – the harness should be replaced
- In the event the pins are to specification or the applicable repairs have been done (for example – Harness replacement or pin replacement) - Reconnect all three connectors

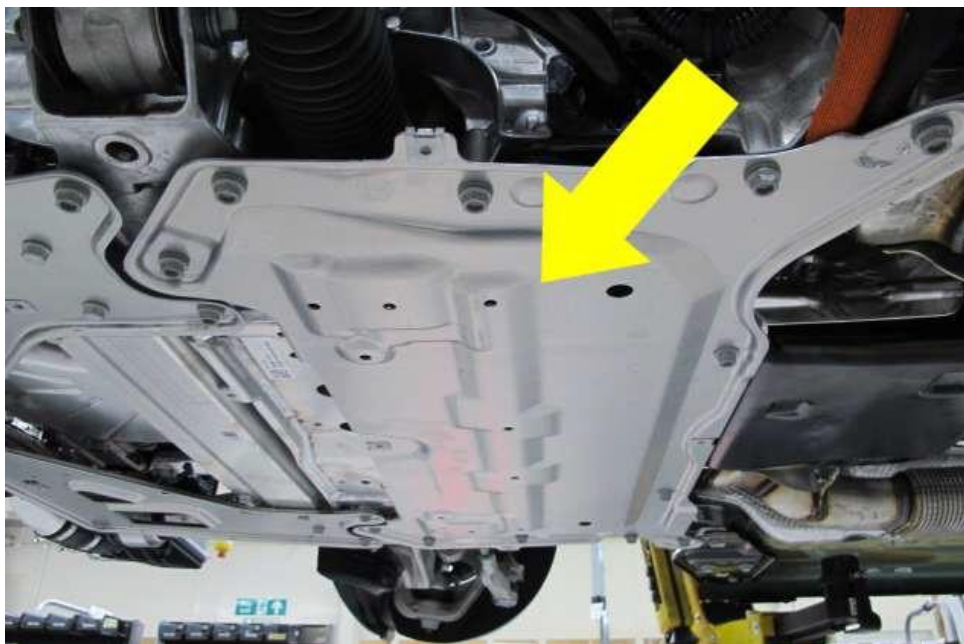
Figure 3

3) Remove the rear subframe support – Rep.Gr 40 (Figure 3)

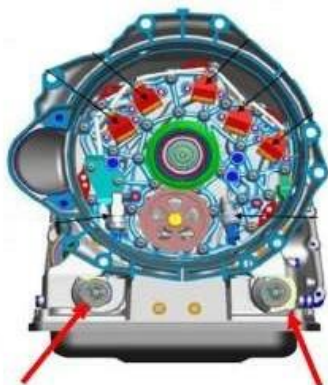
Figure 4

4) Disconnect the connections (Figure 4 - Arrows) from the Mechatronic unit for dual clutch gearbox -J743-

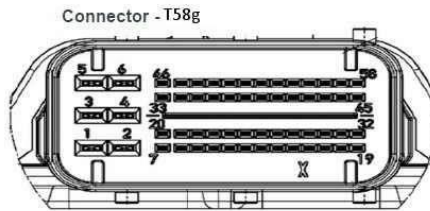
- Referring to the applicable current flow diagram and Figure 5 and 6 - Carry out resistance and pin/terminal grab checks on all disconnected connections from the T58g connector to T20az and T20ay on the harness.

Check T58g to connector T20az

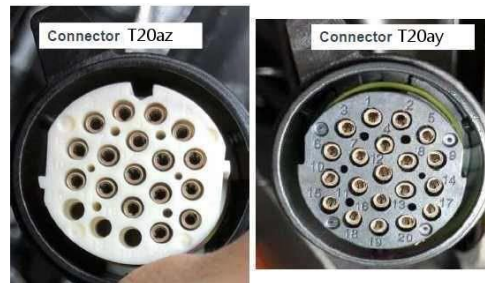
Figure 6

Connector T58g	Power supply	Resistance
PIN 2	co Ground	0.2
PIN 5	co Fuse box SK or SP (20A)	0.2
PIN 55	co TV48	0.3

NOTE: Ensure correct fuse board is located SK = LHD and SP = RHD

NOTE: TV48 MUST be disconnected when conducting resistance/wiring integrity checks

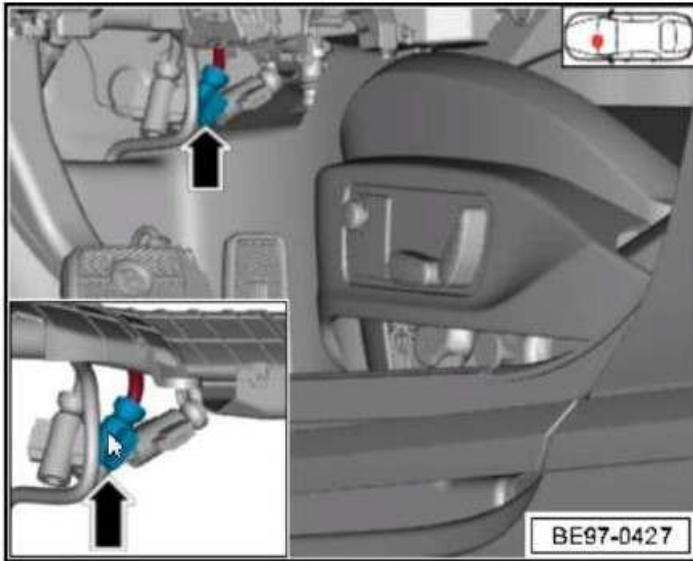
Figure 7

Connector TV48 (Figure 7) MUST also be disconnected when conducting the pin 55 to TV48 resistance check TIP: once the check has been done reconnect TV48
