# Technical Service Bulletin

## 97 Wire harness repairs and documentation

97 22 89 2061976/3 November 17, 2022. Supersedes Technical Service Bulletin Group 97 number 21-82 dated November 22, 2021, for reasons listed below.

Model(s)	Year	VIN Range	Vehicle-Specific Equipment
All Audi vehicles	2018 – 2024	All	Not Applicable

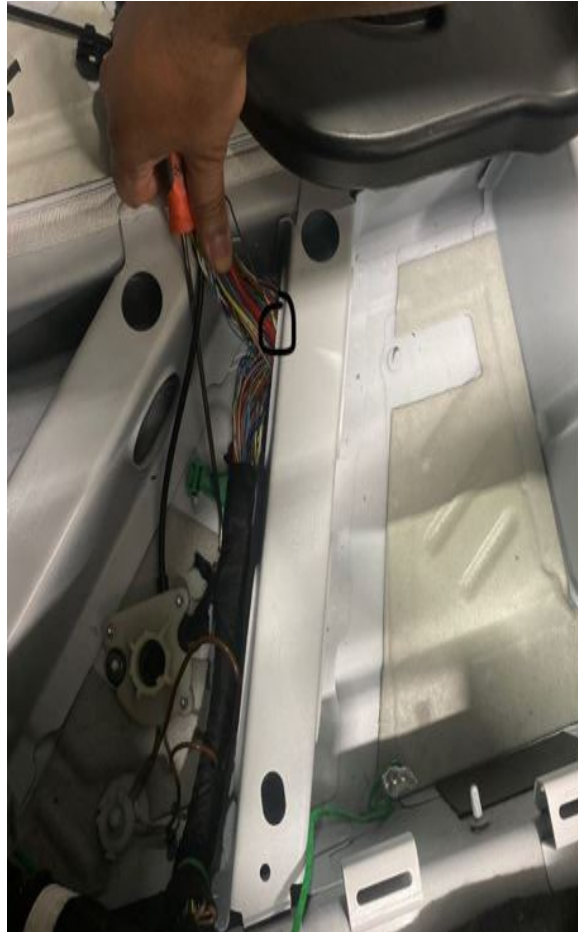
**Example:** Flexray circuit measured .6 ohm to ground with no components connected to the circuit. Short circuit to ground present on the green FlexRay wire between J743 Dual Clutch T23/1 and J533 Data Bus on Board Diagnostic Interface T54/27. Located damaged wire section underneath the driver seat along the frame rail.

Using the description in the example above, the root cause can be clearly identified in Figure 1.

*Figure 1. A perspective view showing the area along the frame rail.*

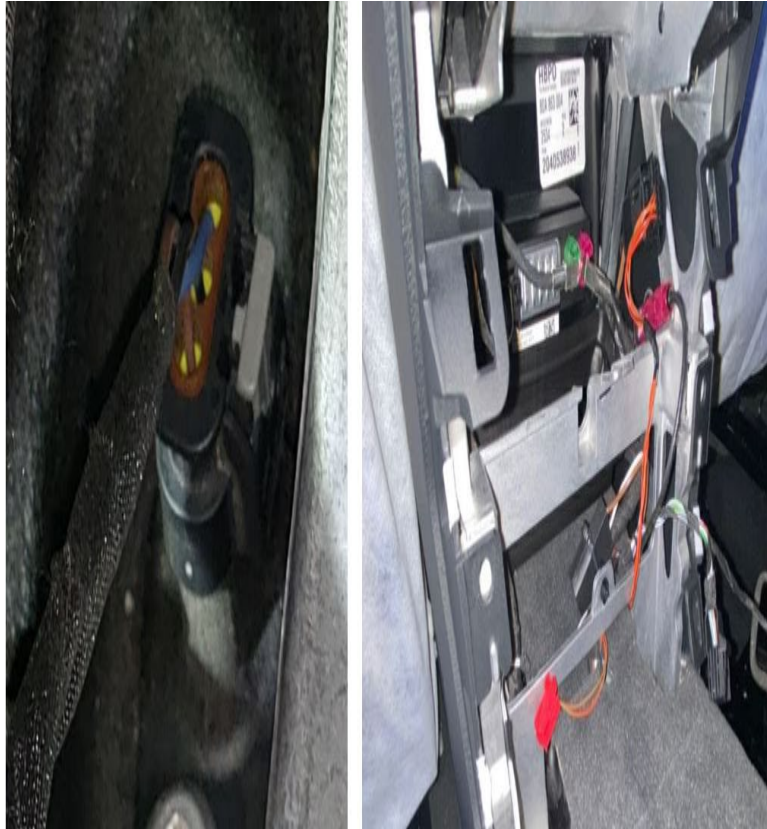
When a harness routing is determined to be the root cause, a photo should be taken to show how the harness was routed in its normal state (Figure 2).

**Figure 2.** G28 crank sensor harness tight (left), Q5 Wireless charging pad harness tight (right).

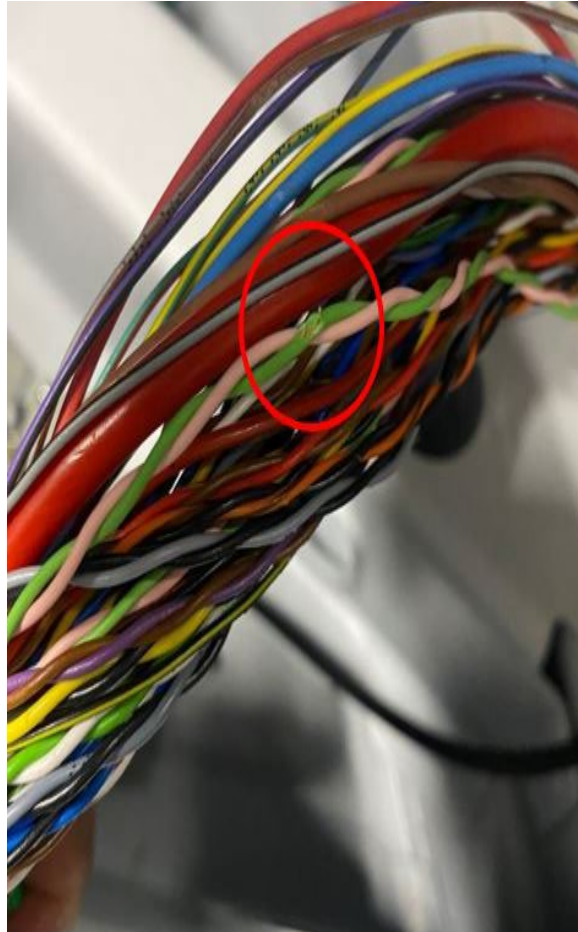
Using the description in the example above, the damage to the FlexRay wire is clearly visible in Figure 3.

*Figure 3. Close-up of the damaged wire.*

- Overlays may be used for diagnosis.
- Retain the affected section of wire that was removed/faulty.
- Repair faulty sections of the wire using VAS1978B.
