Technical product information

Topic	Emergency call function test at PDI
Market area	United States E05 Bentley USA and rest America (6E05)
Brand	Bentley
Transaction No.	2056105/4
Level	EH
Status	Released for publishing
Release date	02-Nov-2022

Emergency call function test required at PDI

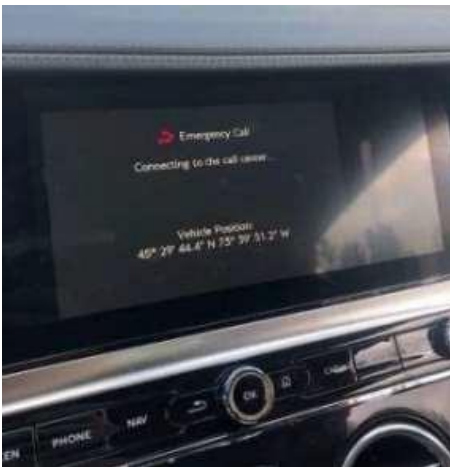
2) Carry out an Emergency call function test to check/confirm if the call is successful/answered, the operative must also check/confirm the Infotainment system is displaying the information as shown in Figure 1

NOTE: The coordinates within Figure 1 are shown as an example only

Should the emergency call system be operational after the first or second attempt (*call successful/answered*) and the Infotainment system is displaying as shown in Figure 1 - No further action is required

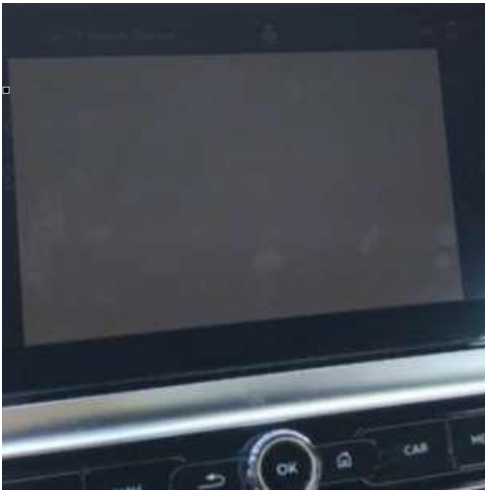
Figure 2

3) If the call is successful/answered but the Infotainment display is blank as (Figure 2) Re-test the Emergency call function a second time

IMPORTANT NOTE: If the Infotainment display remains blank after the second test

If the call is unanswered, raise a DISS query and await feedback from Product support before carrying out any further work
