## Technical product information

<b>Topic</b>	New Continental GT 48V anti-roll bar cable routing
<b>Market area</b>	Bentley; worldwide (2WBE)
<b>Brand</b>	Bentley
<b>Transaction No.</b>	2051712/7
<b>Level</b>	EH
<b>Status</b>	Released for publishing
<b>Release date</b>	02-Nov-2022

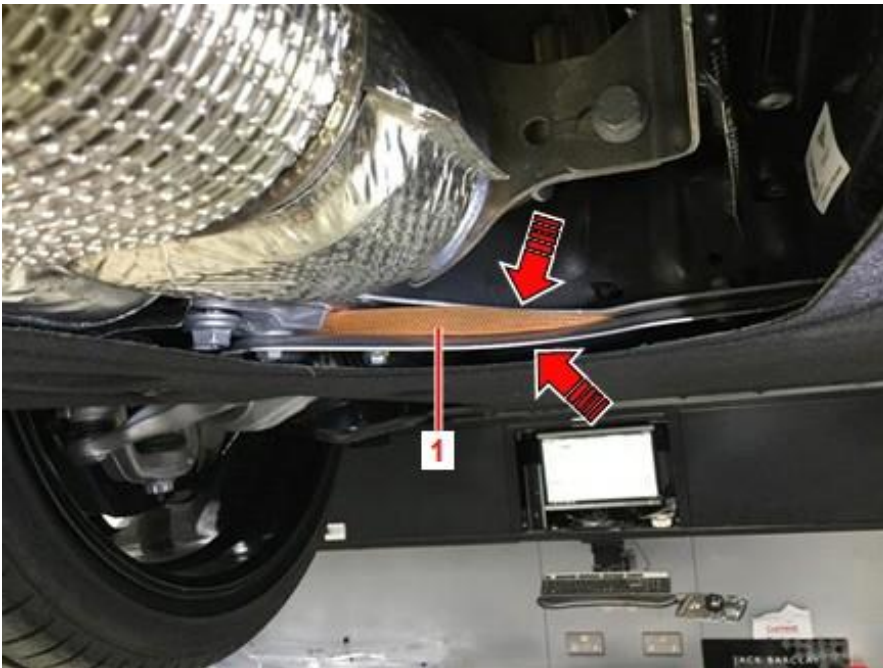
Figure 1

The 48 volt supply cable (1) to the anti-roll bar may appear to be trapped between the front subframe and the engine undersheet (arrows). See Figure 1.

This would be visible on the LH underside of the vehicle and is the normal condition for this routing of cable.  
Do NOT raise a DISS technical query for this concern.
