SERVICE BULLETIN

M1544 2022-11-30

M1544: 2021 TOURING AND TRIKE MECHANICAL CLUTCH CABLE

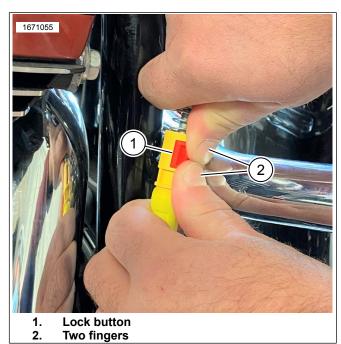
Figure 1. Wrong Procedure

- 1. See Figure 1. Do not use two hands to push-in lock button.
- Do not use any tools to push-in lock button.

- See Figure 2. Use only one finger to push-in lock button.
- Only minimal effort is required to push-in lock button.
- If excessive force is being used, stop and take a closer look at the clutch cable/housing assembly.
- Review procedures and pictures below to make sure button is not being impeded.

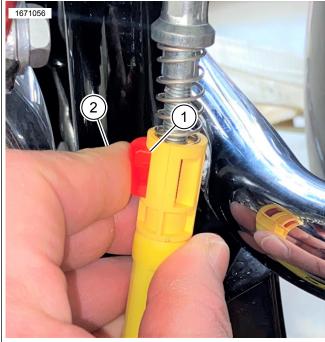
Figure 2. Correct Procedure

- Lock button 1.
- 2. One finger

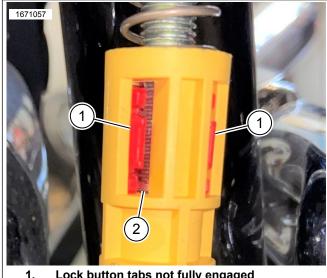
Figure 3. Improperly Installed Button

Improperly installed lock button with tabs misaligned, tabs not properly engaged or upper clutch cable interfering with the lock button, is a sign of incorrect internal adjustment. See the service manual for clutch adjustment.

- 1. See Figure 3. Lock button tabs are not fully engaged (1) because the end of the upper clutch cable (2) is interfering with securing the button.
- See Figure 4. The tabs on lock button tabs are not fully secured.
 - Lock button tabs partially engaged (1). a.
 - b. Lock button tab not fully engaged (2).
- See Figure 5. A misaligned lock button (1, 3) is a sign of an incorrect installation.

- Lock button tabs not fully engaged
- End of upper clutch cable

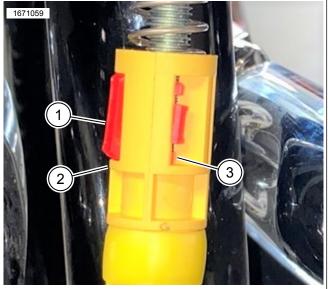
Figure 5. Improperly Installed Button

- 1. Misaligned lock button
- 2. Clutch cable body
- 3. Misaligned lock button

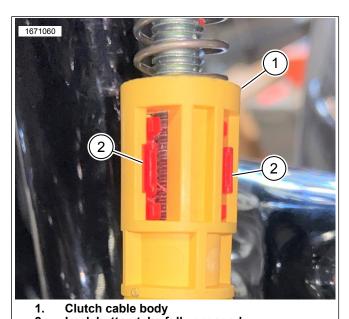
Figure 6. Correctly Installed Button

- 1. See Figure 6. Lock button tabs are fully engaged (2) to clutch cable body (1).
- 2. See Figure 7. A properly aligned lock button (1) should be semi-flush with the rest of the cable clutch assembly.
- 3. The lock button tabs should be fully engaged (2) to the body.
- 4. See Figure 8. Make sure the lock button (4) is installed between the ends of upper clutch cable (1, 3).

Lock button tabs fully engaged

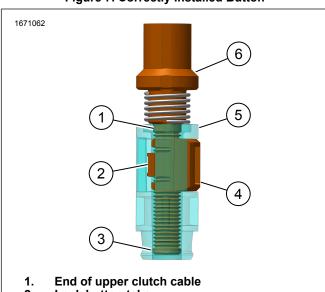
Figure 8. Proper Button Engagement

- 2. Lock button tabs
- 3. End of upper clutch cable
- 4. Lock button
- 5. Clutch cable body
- 6. Upper clutch cable
