# Service Bulletin

Bulletin No.: 22-NA-227

**Subject:** Rear Washer System Inoperative, or Boot to Washer Hose Disconnection and Possible Hose Leaking

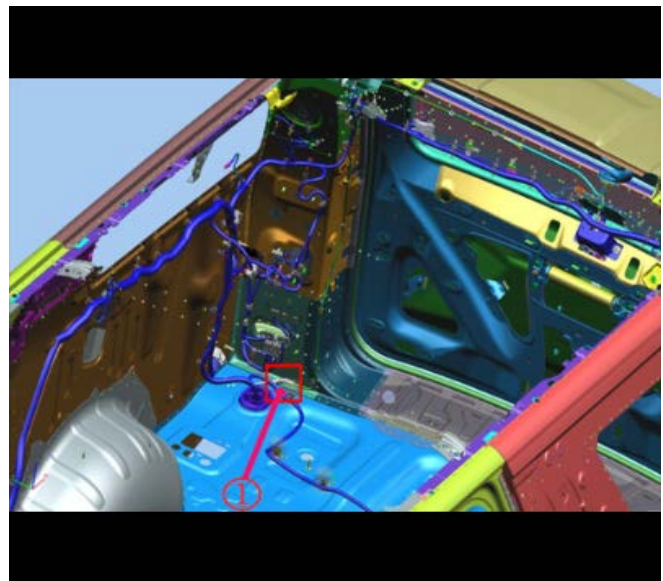
6192930

**Note:** The D-pillar washer hose (1) inside the body is likely the most common connect to show the Condition. Other susceptible locations are noted further below.

1. Remove the passenger quarter lower rear trim panel and enough adjacent trim, to access the passenger side D-pillar washer hose inside the body. Refer to *Quarter Lower Rear Trim Panel Replacement - Right Side*, in SI.

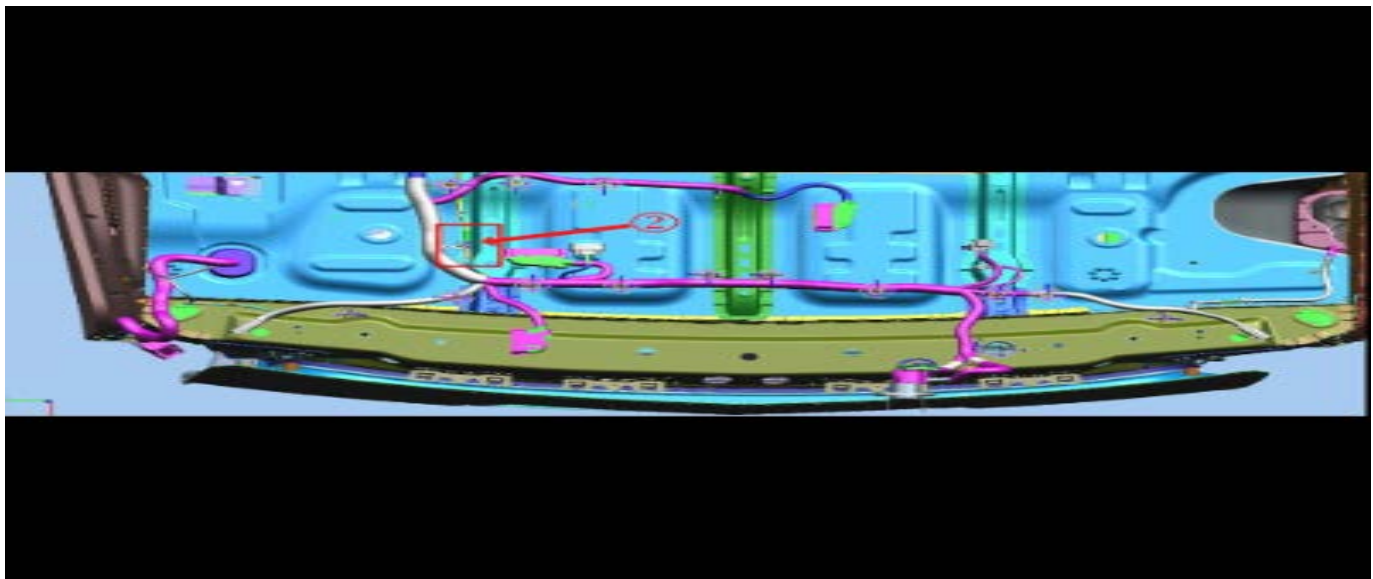
6192932

**Note:** The above view is from the underside of the rear body. The vehicle would need to be positioned on a hoist to inspect this connection location.

3. Access the chassis hose / chassis harness connection (2) that is near the rear spare tire.

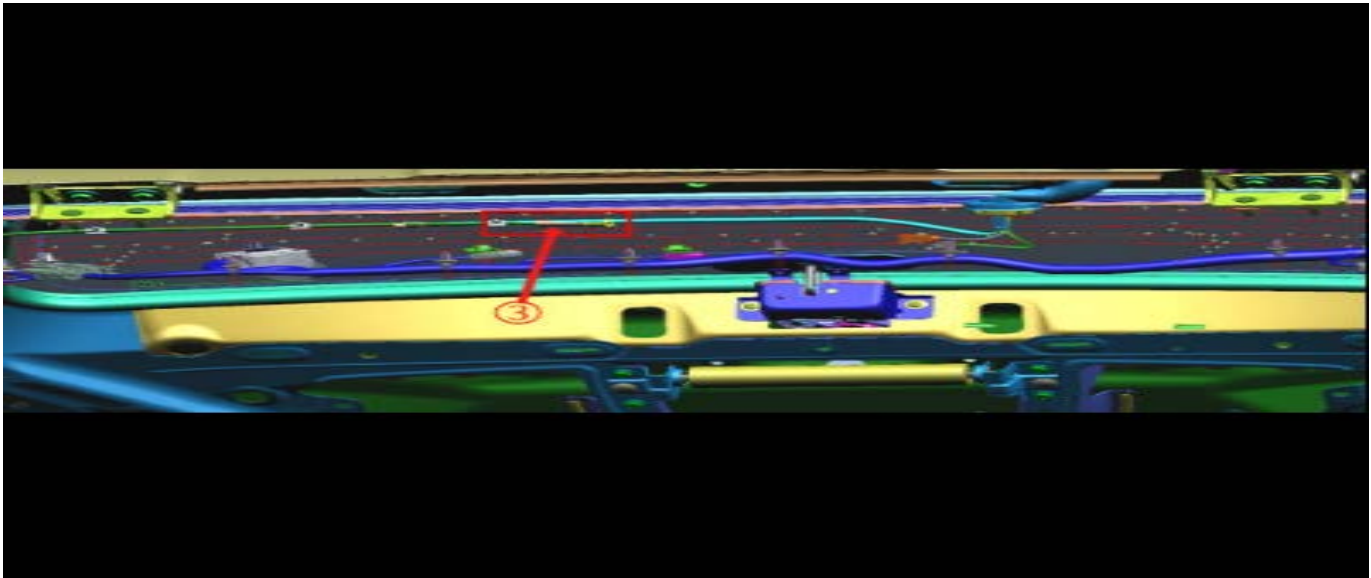
6192933

**Note:** Open the liftgate and partially pull down the headliner to inspect this connection location.

4. Access to the connection shown above (3) is made at the headliner where the D pillar hose is connected to the spoiler washer hose.
5. Verify that the rear washer system is fully functioning.
