Service Bulletin

Bulletin No.: 22-NA-228

Subject: Radio Software Version W165 – Multiple Updates

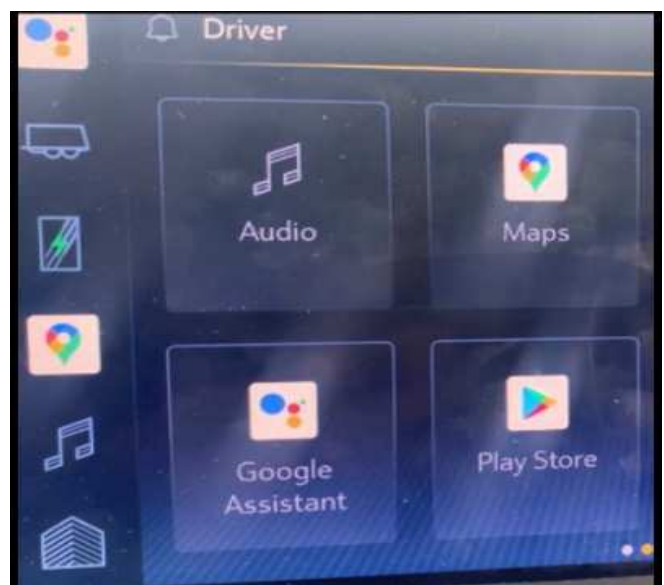
6195491

– Before: Google Icons with color

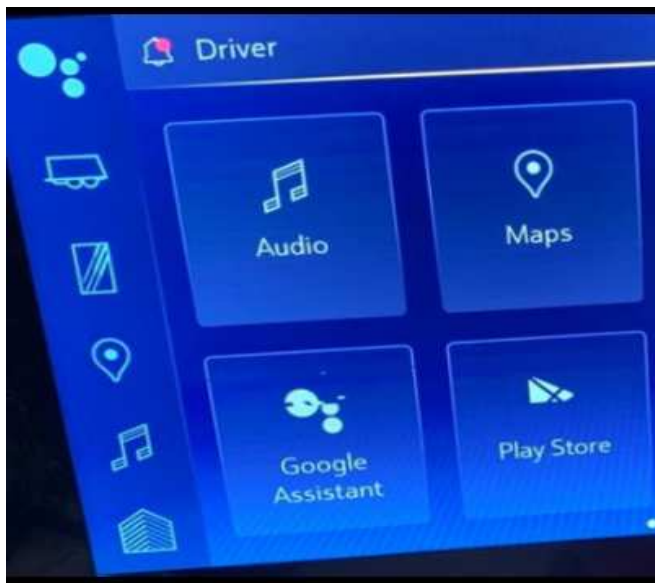
6195492

– After: Google Icons monochromatic
