**Windshield Washer System Spray Nozzle Blocked: Replacing Pump and Spray Nozzles for Windshield Washer System (228/22)**

Model Line: **911 (992)**

Model Year: **As of 2022 up to 2023**

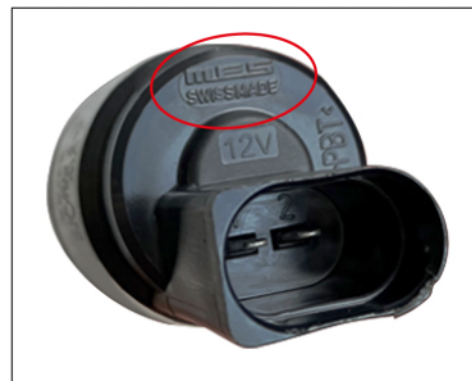
Cause: On vehicles from the above production period, there is a possibility in individual cases that contact between the impeller of the pump and the pump housing may occur during the inlet of the pump for the windshield washer system due to manufacturing tolerances, resulting in particle abrasion. These particles can get into the spray nozzles with the wash water and block them. These are usually early failures.

Only pumps with the marking ⇒ *Affected pump* -**MES SWISSMADE**-are potentially insecure .

Action required: In the case of the described fault pattern on vehicles from the production period mentioned, replace the windshield washer system pump in addition to the affected spray nozzle in order to avoid a repeated occurrence of the fault pattern.
