BISG/Accessory Belt and/or Tensioner May Become Damaged and/or Adrift- INGENIUM I6 3.0L

19-23MY Land Rover Defender, Discovery, Range Rover, RR Sport, RR Velar , Jaguar F-PACE

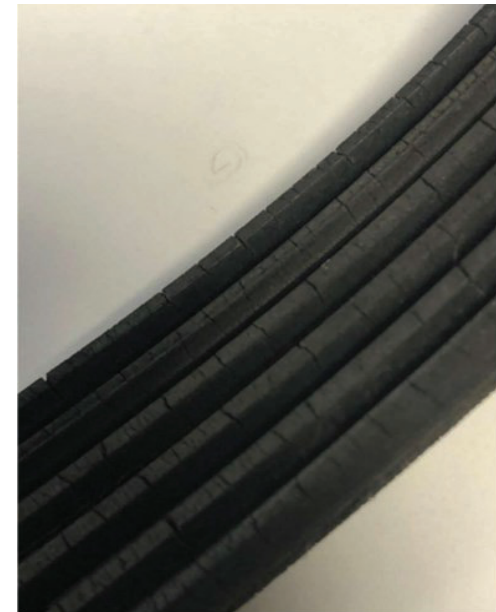
- Presence of oil or coolant on and around the primary and secondary belts or on the pulleys
- Evidence of heat cracks on the primary or secondary belt (see image attached)

- Tensioner, primary belt, and secondary belt.
- If damage is present please replace belts and tensioner.
