# Technical Service Bulletin

SUBJECT:		No: <b>TSB-22-54-005</b>	
<b>FOG OR DEW CONDENSATION IN EXTERIOR LIGHTS (HEADLIGHTS/TAILLIGHTS)</b>		DATE: <b>November 2022</b>	
		MODEL: <b>All Models</b>	
<b>CIRCULATE TO:</b>	<input type="checkbox"/> GENERAL MANAGER	<input checked="" type="checkbox"/> PARTS MANAGER	<input checked="" type="checkbox"/> TECHNICIAN
<input checked="" type="checkbox"/> SERVICE ADVISOR	<input checked="" type="checkbox"/> SERVICE MANAGER	<input type="checkbox"/> WARRANTY PROCESSOR	<input checked="" type="checkbox"/> SALES MANAGER

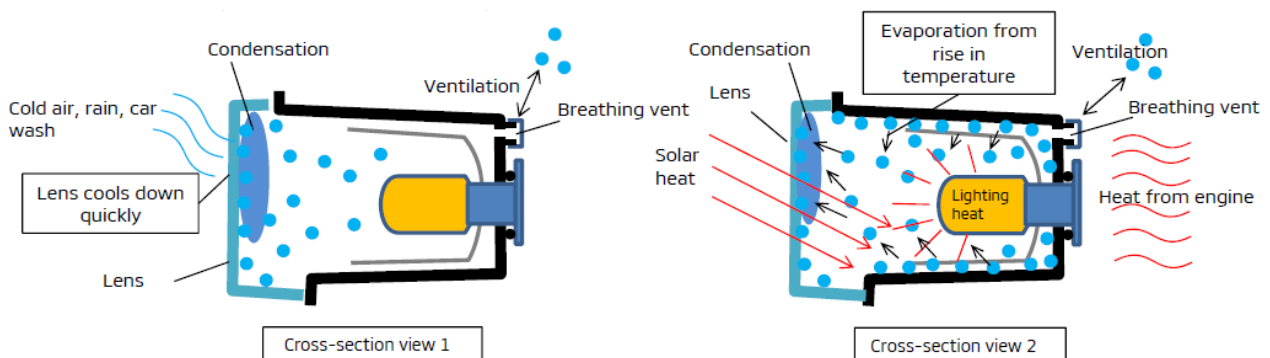
- If a lens gets cold quickly (due to cold air, rain, or car wash) the moisture holding capacity of air decreases around the inside surface of the lens. In this situation, the excess water in the air forms droplets, causing condensation (Cross-section view 1).
- After the temperature rises in a head or taillight (due to engine heat, sun, light, etc), the moisture on the plastic inside the lights cools down around the surface of the lens and becomes tiny water droplets causing condensation (Cross-section view 2).

The condensation typically evaporates by ventilation through the breathing vent after vehicles are left for approximately an hour.

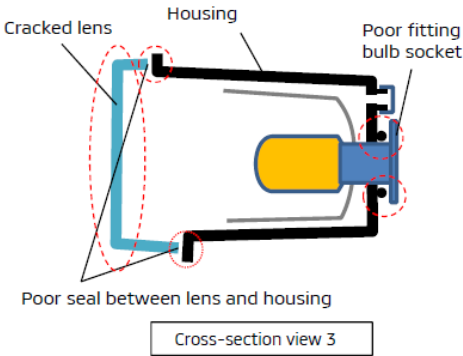
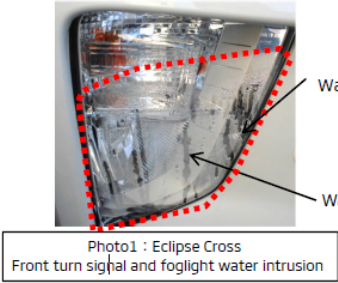
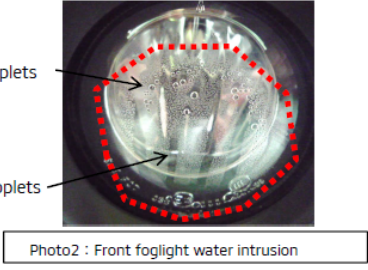
WATER ACCUMULATION CAUSE (Continued)

Water may enter the light if the component is damaged with a cracked lens, poor seal between the lens and housing, or from a poorly fitting bulb socket (Cross-section view 3). These conditions cause larger droplets of water on the inside surface of the lens (Photos 1 & 2).

However, if an accumulation of water is found in the light or if condensation does not disappear after drying in conditions mentioned above, inspect for possible damage such as a cracked lens, poor sealing between the lens and housing, or a poorly fitted bulb socket.
