HYUNDAI Technical Service Bulletin

GROUP CAMPAIGN	NUMBER 22-01-039H
DATE DECEMBER 2022	MODEL(S) NEXO (FE)

SUBJECT: CSP SOFTWARE UPDATE FOR THE STACK COOLANT PUMP
(SERVICE CAMPAIGN T7K)

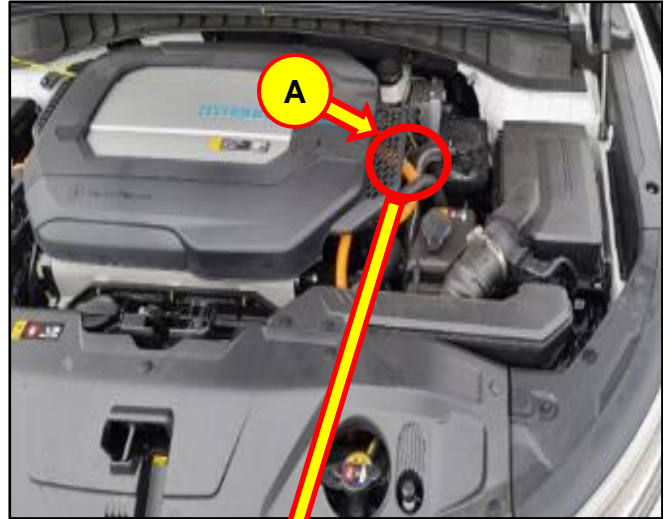
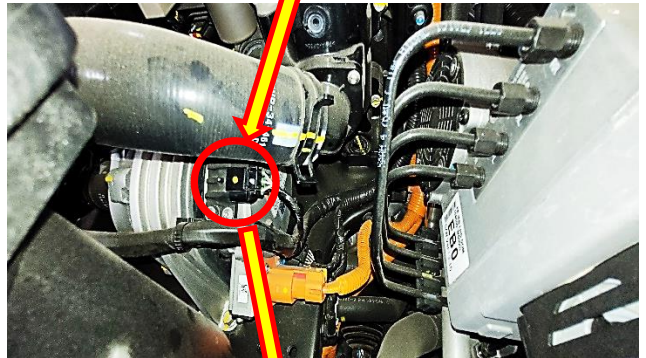
- The CSP connector is located just below the stack coolant pump outlet hose.

1. Open the hood of the vehicle.
2. Disconnect the (CSP) low voltage connector (A) from the stack coolant pump.

3. Attach the low voltage update cable (B) to the connector on the stack coolant pump.
4. Before updating the CSP software, ensure the cables are fully connected (C).

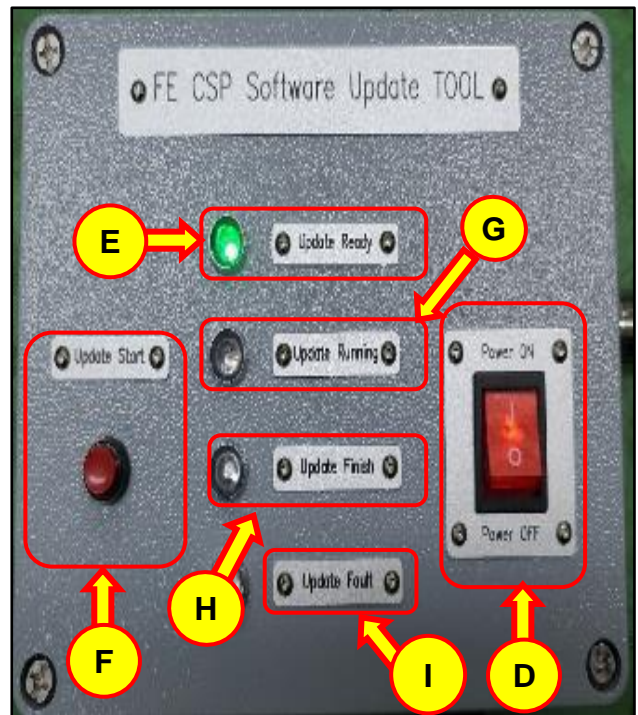
If the **Update Fault** light (I) illuminates, recheck the connections and retry the update. After retrying the update and the fault light continues to illuminate, contact Hyundai Techline.

8. The **Update Finish** light (H) will illuminate when the software update is complete.
