95B.III – 2022 Macan Transfer Box Shudder/Jerk at Slower Speeds

Vehicles Affected

Models	Model Year	Model Type	VIN Range	Vehicle-Specific Equipment
Macan	2022	95B	n/a	All

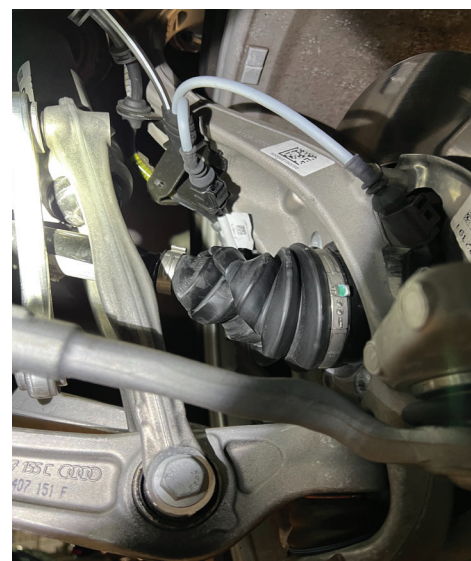
Figure 1- Driveshaft detached from splines at outer joint

Repeated occurrences of the sharp increase in torque may cause one or both of the driveshafts to detach from the splines on the wheel hub (outer joint). The separation of the driveshaft from the wheel hub may cause a clicking or clunking noise during low speed maneuvering.

2. Visually inspect both front driveshafts for excessive play. If either of the driveshafts are detached from the splines in the wheel hub, please replace the detached front driveshaft(s) as instructed in *WM 404119 – Removing and installing the front drive shaft*.
