Technical Service Bulletin: TSB220216 Released Date: 01-Nov-2022

C500D6RE Exhaust Bellow Cracking Issue

C500D6RE

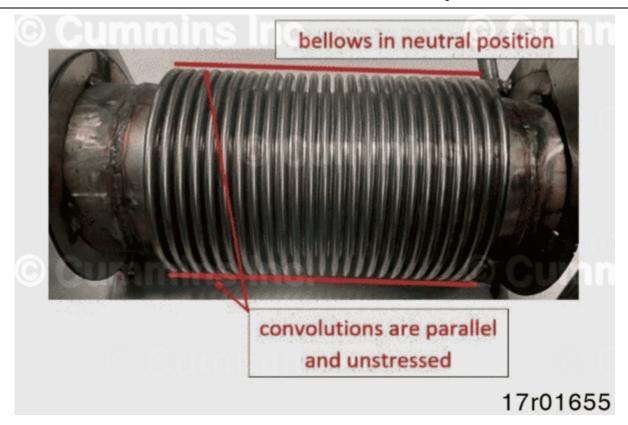
Figure 13, Neutral Bellow Reference

Assembly issue putting pressure on the exhaust bellow causing it to crack

D. Slide EXT29-0002-W10 over turbo elbow (Do NOT install Riker Band Clamp at this point)

Note: ensure bellow is in a neutral position – If centerline of bellows is not in-line with adjacent tubing, adjust assemblies at the overlap joints until all offsets are removed

- E. Install RIKER-TEC600 at each joint
- Ei. Evenly tighten bolts and torque to 50lbs
- F. Double check bellows is still in neutral position
