SIB 51 15 22 GROANING SOUND IN THE D-PILLAR AREA

2022-10-25

E-Series	Model Description	Production Date
G26	4 Series Gran Coupe	July 1, 2021 – August 31, 2022

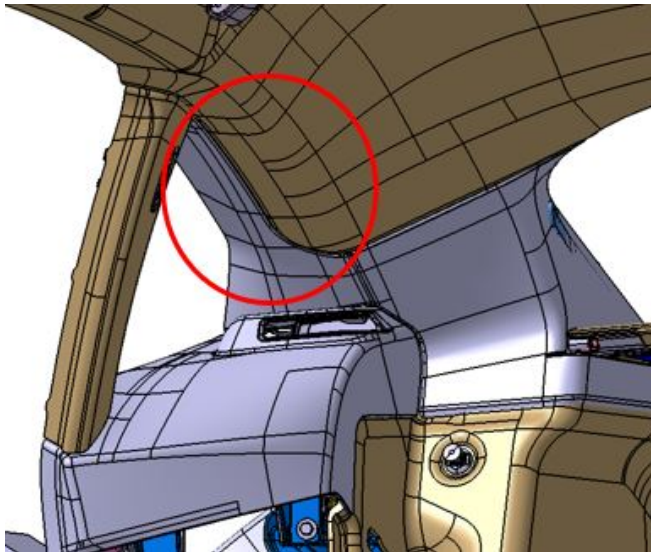
While driving on a rough road, a groaning sound is heard coming from the D-pillar trim panel and the headliner.

Unfavorable friction between the D-pillar trim panel and the headliner.

Apply film tape to the D-pillar as shown in the photo below. The film tape surface acts as a friction reducer.
