GLOBAL SAFETY FIELD INVESTIGATIONS  
DCS6364  
URGENT - DISTRIBUTE IMMEDIATELY

Subject: REVISION: N212354520-03 - Customer Satisfaction Program  
Heated Vented Seats Retrofit  
Front Seat Heater Vent Module and Programming  
Population Update

## N212354520 Heated Vented Seats Retrofit - Front Seats Only

**Revision:** 03

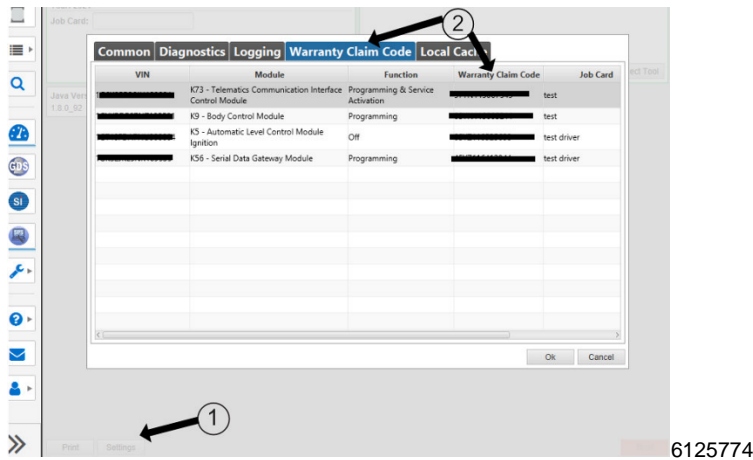
If the Warranty Claim Code was not recorded on the Job Card, the code can be retrieved in the SPS2 system as follows:

1. Open TLC on the computer used to program the vehicle.
2. Select and start SPS2.
3. Select Settings (1).
4. Select the Warranty Claim Code tab (2).

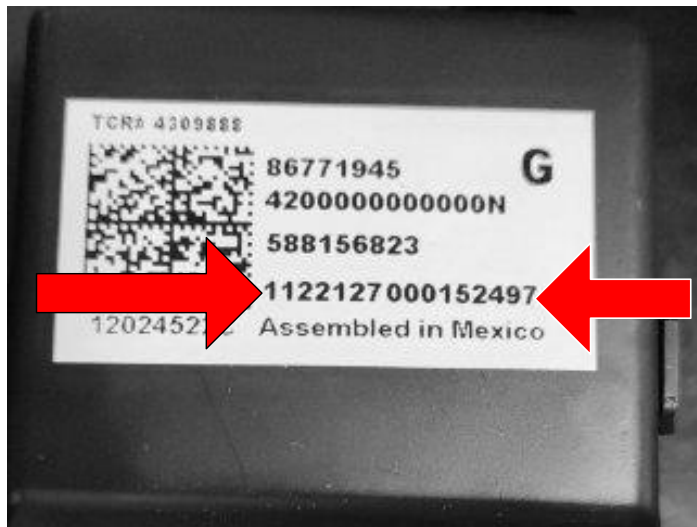
6098078

Record the serial number on the front seat heater vent control module labels.

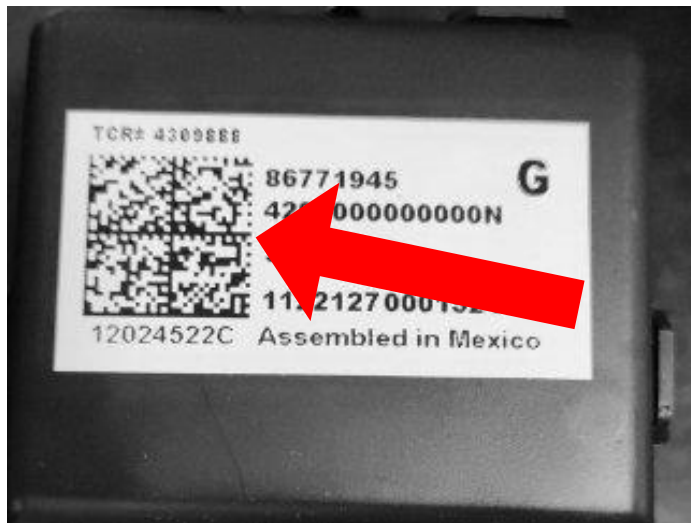
6098077

If the App is already loaded to your phone, simply:

1. Scan the VIN (door pillar QR code or windshield VIN barcode) and
2. Scan the new part (QR code) and
3. Check the information and if correct then, Submit.
