Technical Service Bulletin

70 Noises from B-pillar area

70 22 76 2048430/4 December 1, 2022. Supersedes Technical Service Bulletin Group 70 number 22-75 dated September 1, 2022, for reasons listed below.

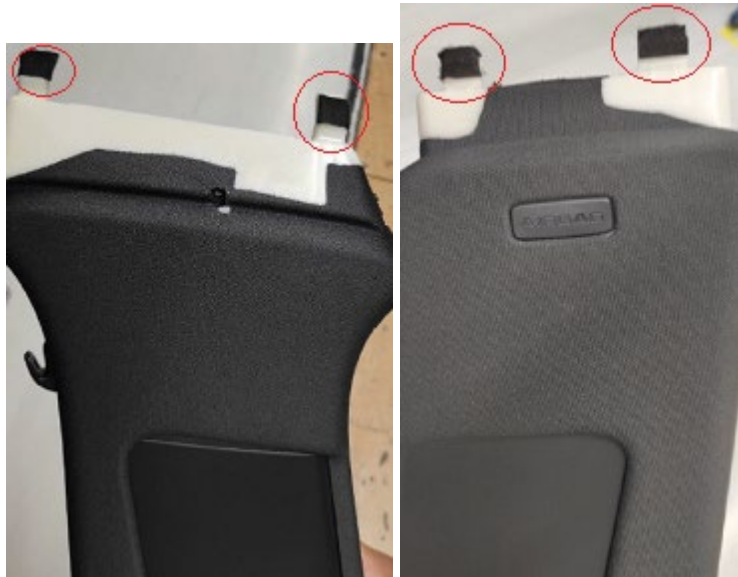
Figure 1-2. D004350A2 tape applied to the upper mounting points of the Q7/Q8 upper B-Pillar trim

2. Apply two pieces of webbing adhesive tape **D004350A2** to the upper mounting points of the B-Pillar trim (Figure 1-2).

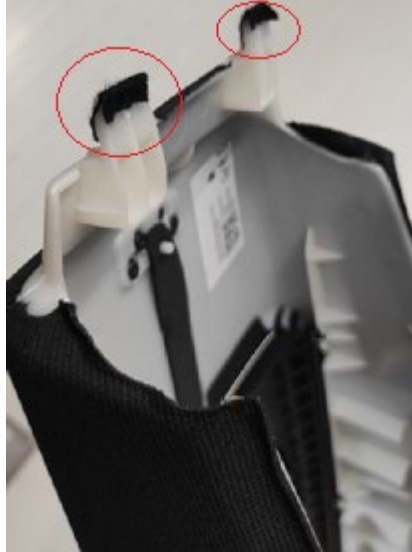
Figure 3. Webbing adhesive tape folded over on mounting points

For better adhesion to the trim mounting points, cut the webbing adhesive tape long enough to fold the tape over (Figure 3).

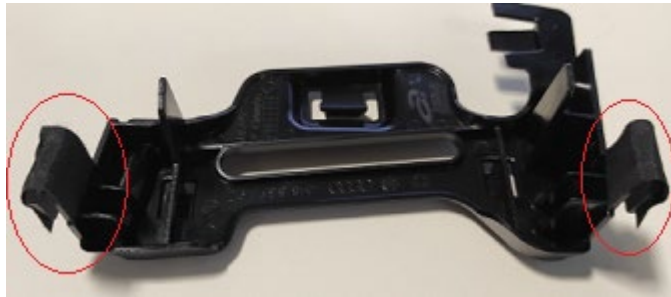
Figure 4. D373125A2 tape applied to the lower mounting points of the Q7/Q8 upper B-Pillar trim.

3. Apply two pieces of fleece adhesive tape **D373125A2** to the lower mounting points of the B-Pillar trim (Figure 4).

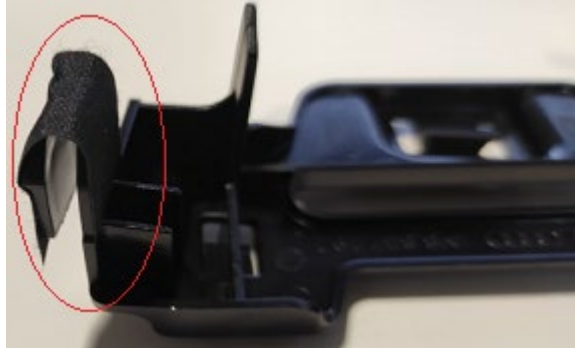
Figure 5. Fleece adhesive tape folded over on mounting points

For better adhesion to the trim mounting points, cut the fleece adhesive tape long enough to fold it over (Figure 5).
