Technical Service Bulletin

90 Head-up display: Navigation directions are not displayed

90 22 85 2067174/2 December 1, 2022. Supersedes Technical Service Bulletin Group 90 number 22-63 dated May 25, 2022, for reasons listed below.

Model(s)	Year	VIN Range	Vehicle-Specific Equipment
e-tron GT, and RS e-tron GT	2022	All	Head Up Display

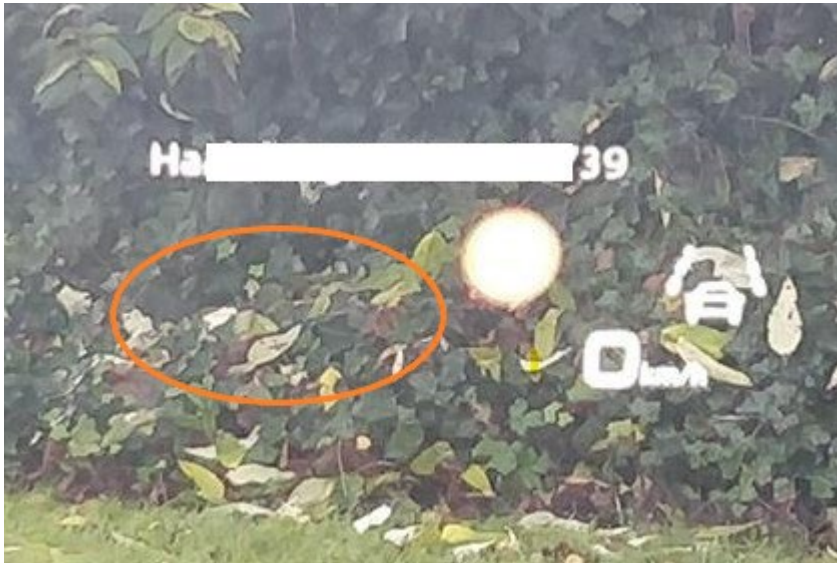
- No navigation map or directions are displayed on the heads-up display (HUD) (Figure 1).
- All other information is displayed properly.

Figure 1. Heads-up display without navigation information displayed.

A software-related malfunction in the HUD can cause the navigation information not to be displayed.

1. Follow all instructions in TSB 2011732: *00 Software Version Management (SVM), operating instructions.*
2. Update the HUD (diag. addr. 0082) using the SVM action code as listed in the table below, if necessary:
