Technical Service Bulletin

91 MIB3: lower display is flickering or distorted

91 22 53 2068721/1 December 1, 2022.

Model(s)	Year	VIN Range	Vehicle-Specific Equipment
A6, A6 allroad, S6, RS 6 Avant, A7, A7 e quattro, S7, and RS 7	2021 – 2022	All	Not Applicable

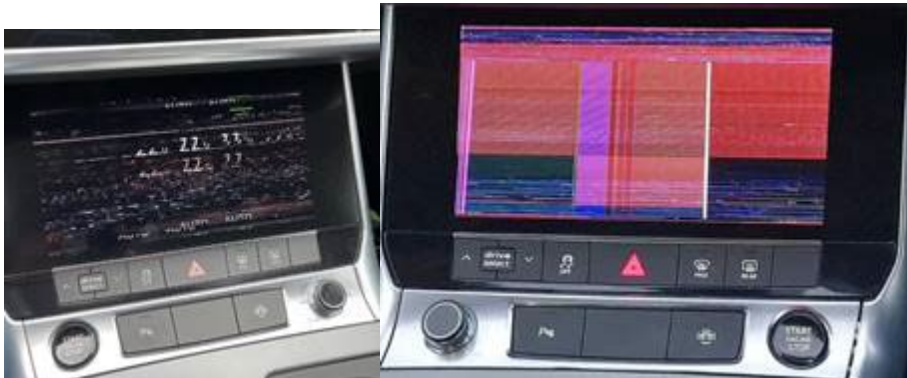
- The lower MMI display (J686) flickers sporadically, or the display area looks distorted (Figure 1).
- HVAC settings change by themselves.
- Touch inputs are detected on the lower display without user interaction.

Figure 1: Examples of the distorted/flickering screen.

A software malfunction in the lower MMI display may cause it to become distorted or flicker.

- Update the MIB3 Display (J686) using either Method 1 or Method 2 according to TSB 2060523: *91 MIB3 Software Update Instructions* and use SVM code **636S003**.
