TO: Mercedes-Benz Dealer Principals, General Managers, Sales Managers, Service Managers, Parts Managers	FROM: Anthony Washington, Department Manager, Regulations and Certifications
Re: Service Campaign Notification Model 907 (Sprinter) Model Year 2022 Retrofit PTC Heater	DATE: August, 2022

Service Campaign Bulletin

Campaign No. 2022070014 August, 2022

SUBJECT: **Model 907 Model Year 2022**
Retrofit PTC Heater

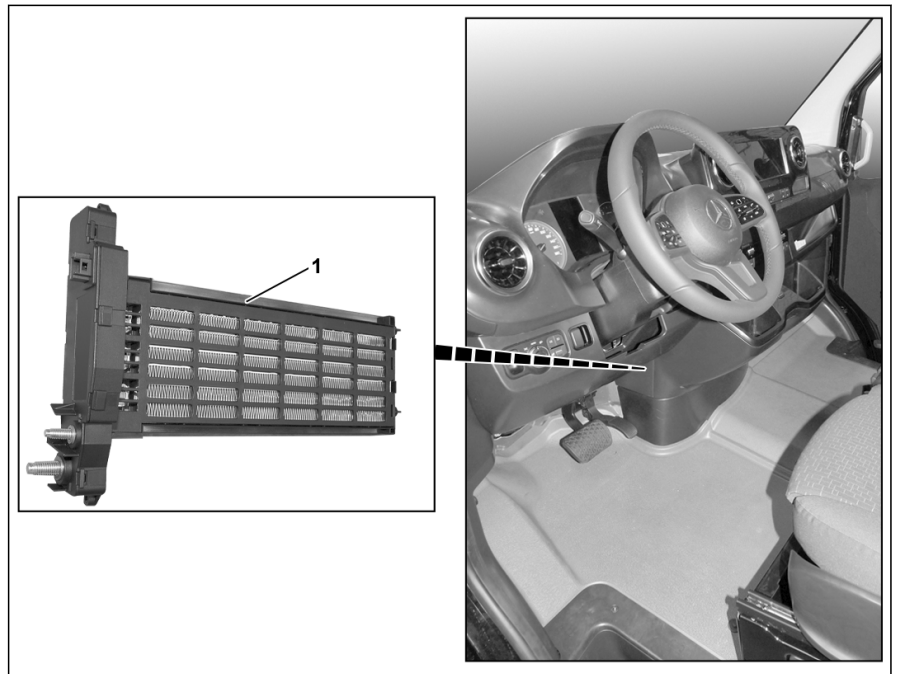
D83.70-A021-06

1 PTC heater booster
