TO: Mercedes-Benz Dealer Principals, General Managers, Sales Managers, Service Managers, Parts Managers	FROM: Anthony Washington, Department Manager, Regulations and Certifications
Re: Launch Recall Campaign Notification Check Generator/Steering Harness Connections Model – Sprinter 907 Model Year - 2021 VS3LE54ELE	DATE: August, 2022

Campaign No. 2022080003, August, 2022

SUBJECT: **Model 907 Sprinter, Model Year 2021**
Check generator and steering wiring harness connections

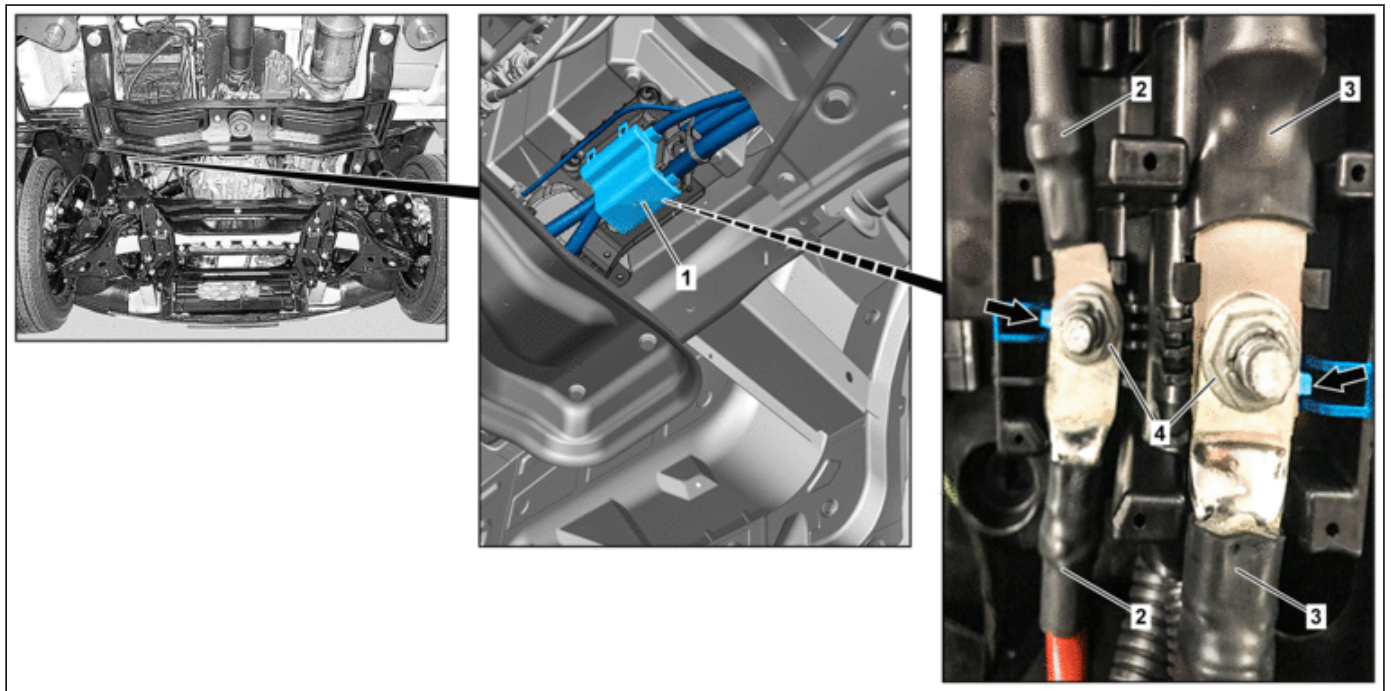
D54.18-A048-79

MBAG has determined that on certain Sprinter (platform 907) vehicles, the wiring harness of the generator may have been interchanged with the wiring harness of the electric power steering system. In the event of an additional electrical fault (e.g. unrelated damage to the steering wiring harness), the interchange of the two different fused lines could result in an overload of the wiring harness of the electric power steering. As a consequence, a risk of fire cannot be completely ruled out.

To do so, check whether electric lines (2, 3) are installed as shown. The cross sections of the electric lines (2, 3) that are screwed to one other must be the same. Lugs (arrows) must line up with guides. If electric lines (2, 3) are correctly screwed to each other, ↓ continue with operation step 10 and finish measure. If electric lines (2, 3) are not correctly screwed to each other, ↓ continue with operation step 6.

Nuts (4) can be reused.	
8	Position electric lines (2, 3) correctly.

Observe the following: The cross sections of the electric lines (2, 3) that are screwed to one other must be the same. Lugs (arrows) must line up with guides.	
9	Attach nuts (4).

Nm Nut, positive line to battery positive line connection on underbody	BA54.18-Z-1002-02KTS
