Technical Service Bulletin

01 MIL on (DTC P0300, P130A, and/or P0301 through P0304)

01 13 08 2033561/2 June 21, 2013. Supersedes Technical Service Bulletin Group 01 number 13-95 dated May 13, 2013 for reasons listed below.

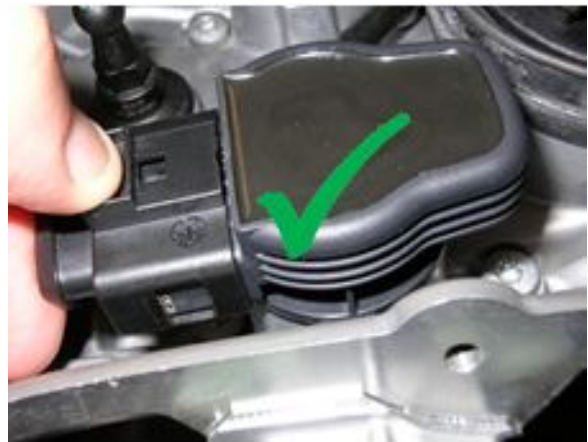
Figure 1. Correct method of disconnecting the ignition coil.

1. Confirm that misfire faults are stored in the ECM memory.
2. Disconnect the connectors from the ignition coils by first pushing the connector towards the ignition coil, then pulling the release tab with thumb, then pulling the connector off the ignition coil (Figure 1).

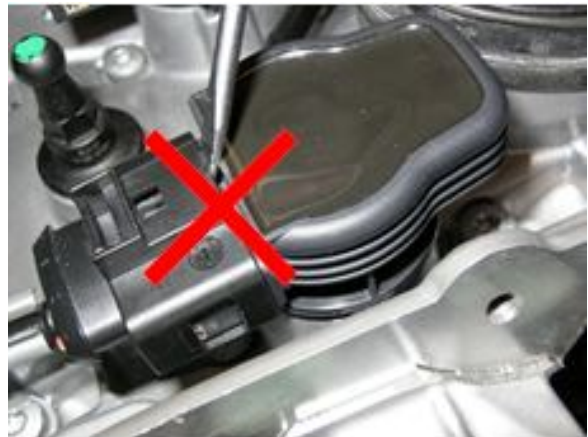
**Note:** Never use a screw driver, pick or any other tool to unlock and remove the connector, as damage to the connector may occur (Figures 2 and 3).

Figure 2. Incorrect method of disconnecting the ignition coil.

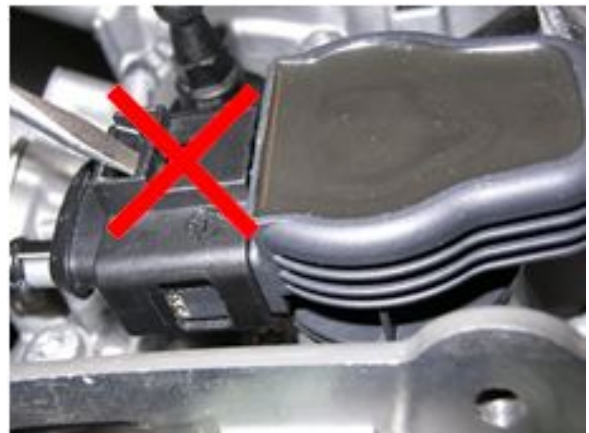
Figure 3. Incorrect method of disconnecting the ignition coil.

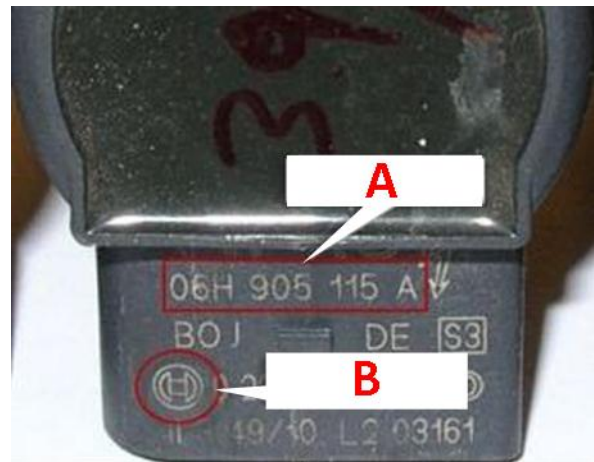
Some of the Bosch ignition coils installed in the affected vehicles may fail prematurely.

3. Check the part number of the coils (Figure 3). If one of the following part numbers is installed, all four ignition coils will need to be replaced:

- 06H 905 115
- 06H 905 115 A
- 06H 905 115 B

Figure 3. A) part number, B) Bosch symbol.

4. Replace all four ignition coils with part number **07K905715F** (ELDOR).

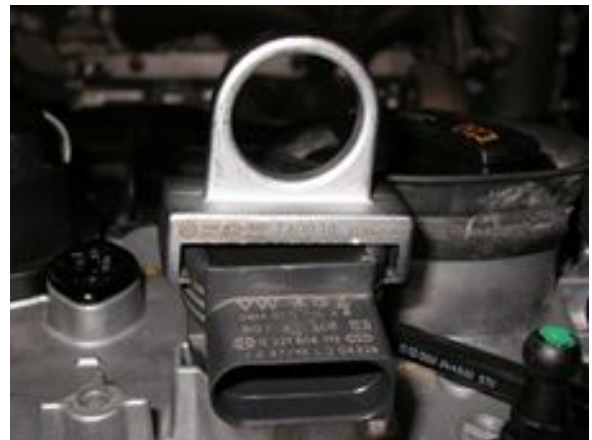
Figure 4. Special tool *T40039*.

Note: Always use special tool *T40039* to remove ignition coils (Figure 4).
