Timing Gear Plate, Inspection

V-212-001

(December 2022)

All Volvo Powered Trucks 2017 to current

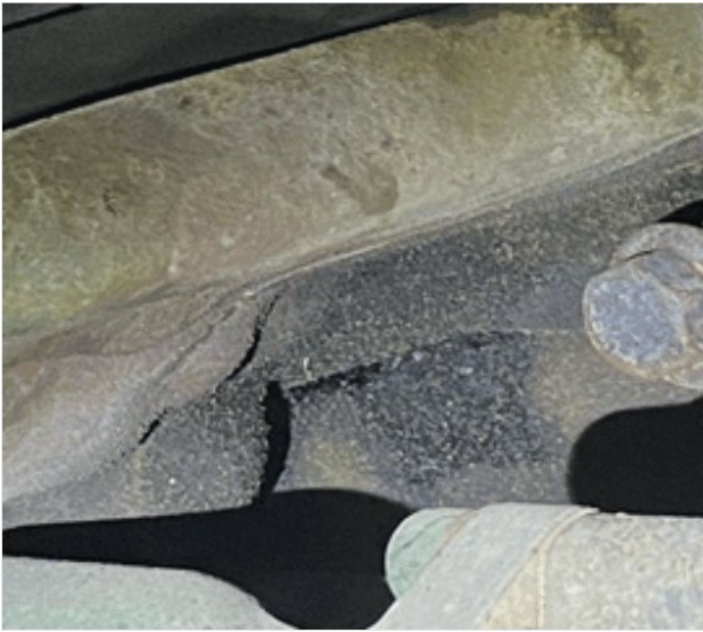
Reference images of an oil weep (not a valid warrantable repair)

Dark spot or stain

Note: An oil weep is a normal condition seen around mechanical joints and does not require a repair.

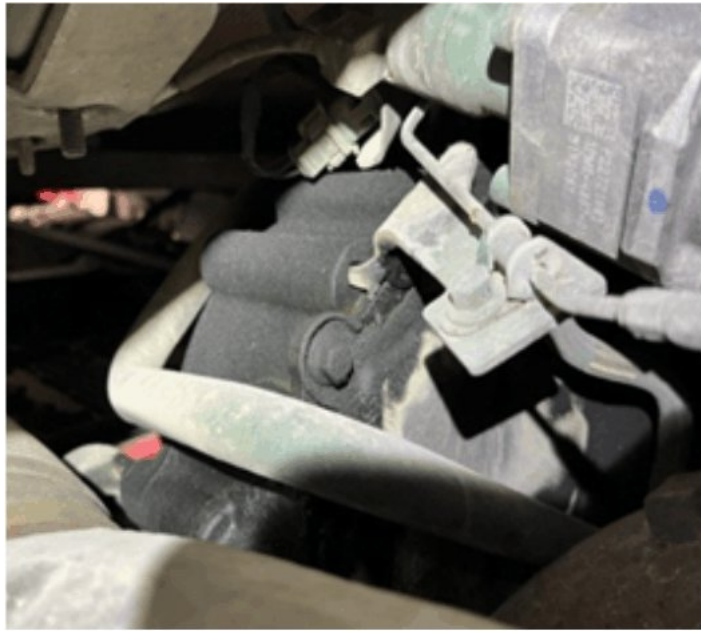
Collection of dirt and dust (not active)

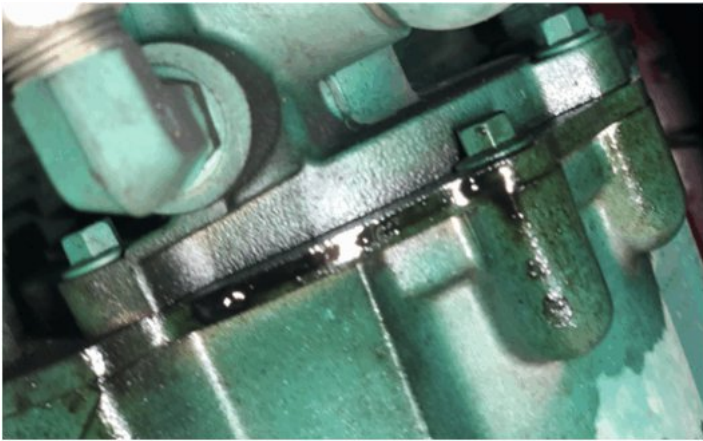
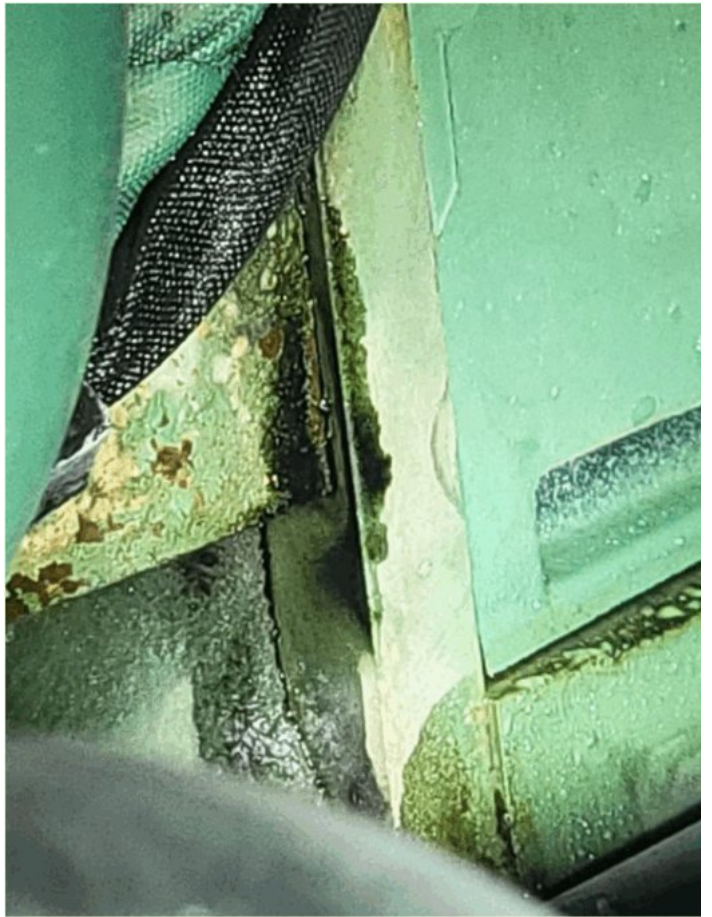
Reference images for an oil leak (valid warrantable repair)

Oil actively leaking

Note: An active leak is the only leak that is considered a valid warrantable repair.

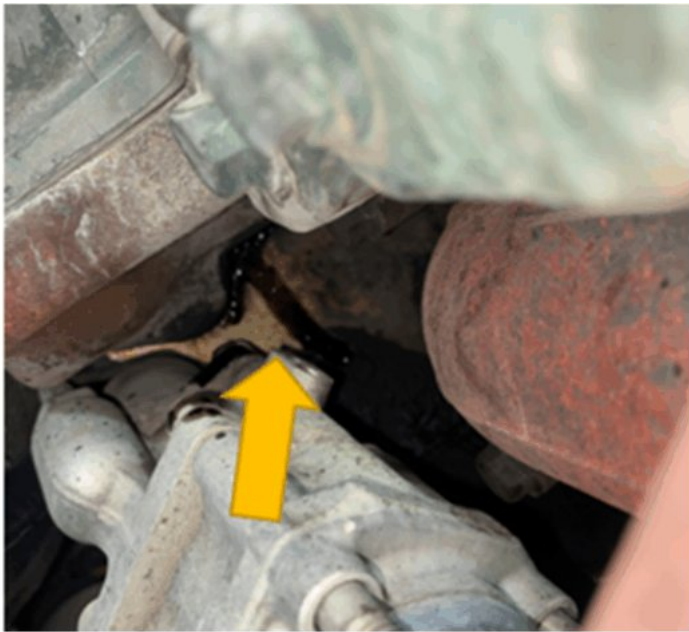
Oil actively running down joint

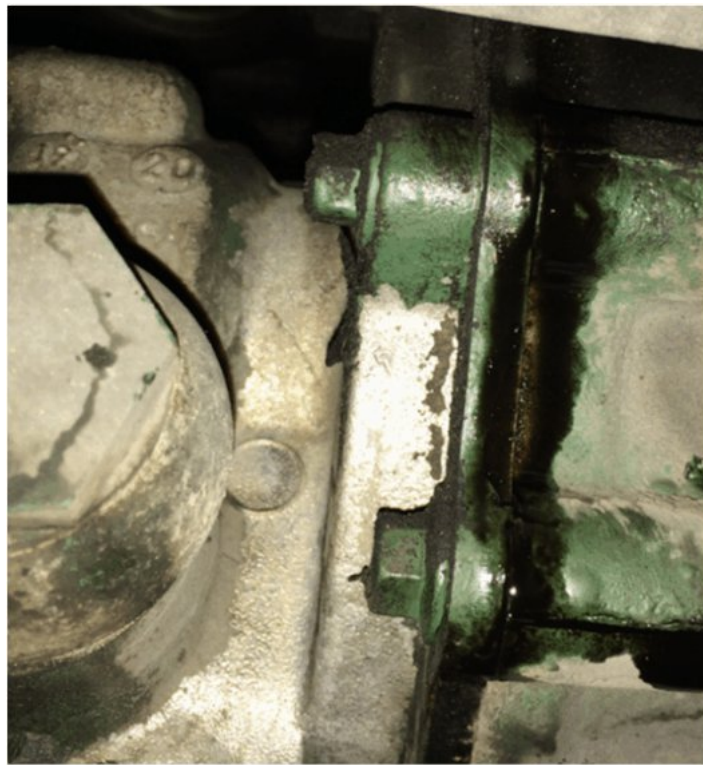
Oil Accumulating
